Indian Railways
Centre for Design and Development
Chittaranjan Locomotive Works
PO: Chittaranjan, West Bengal. PIN: 713331
E-mail: cdndclw@gmail.com, Ph: (+91)341- 2525578

Sub: Permission for downloading trial software for M/s. Siemens make Three phase drive propulsion.

Joint Note

Sub: Demonstration of 2.09 software trial

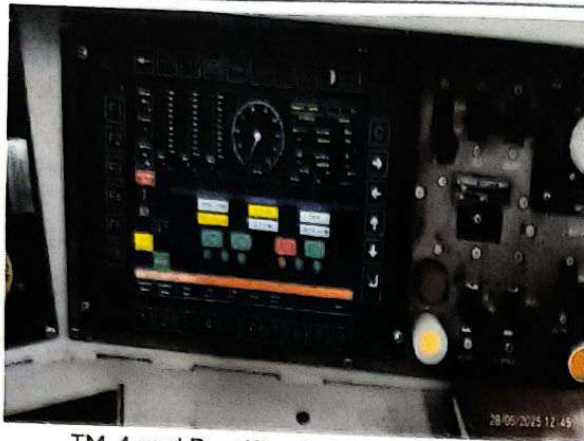
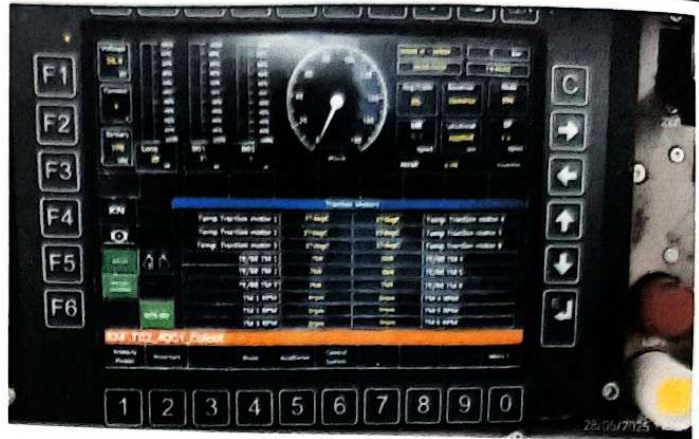
- 3) 1/4th redundancy was working normal with crew messages for driver and diagnostic event. The fault message code for the rectifier module 2 in TCC1 was 0333 and rectifier module 1 in TCC-2 was 0334 and after isolation, nodes were reaching 596 with TE of 5-20 KN in standstill conditions. The same is depicted below in the snapshot for rectifiers of both TCC.

TM-4 and Rectifier 1 of TC-2 pictogram

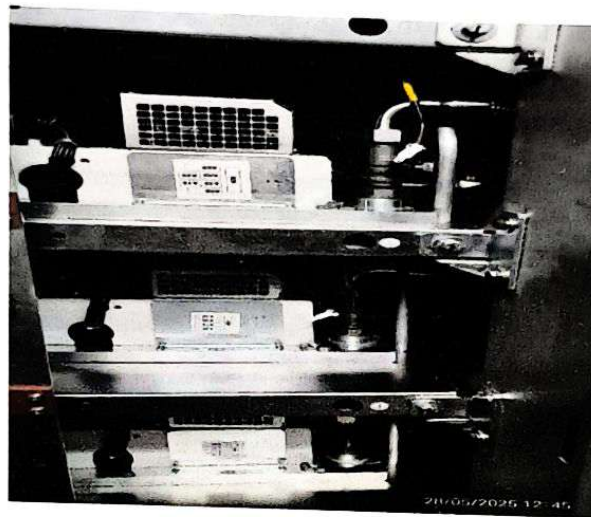
TCC2 Rectifier-1 & TM4 cutout by removing X1 connector.

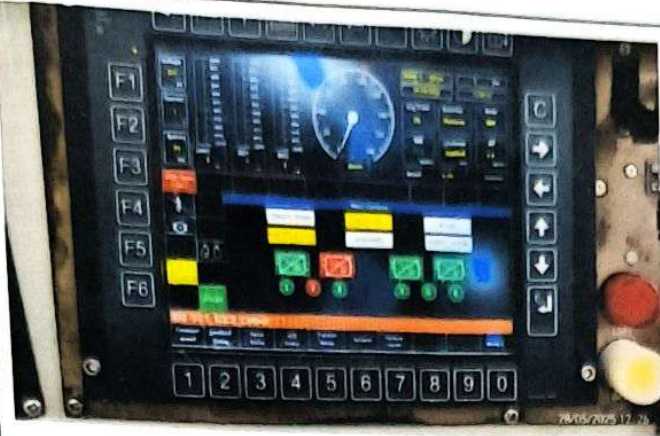
- 2) It is to be noted that during the isolation of one rectifier of any TCC, traction of TM2/TM5 will be blocked to compensate for the power loss from the line side. This is basically fulfilling the requirement of 1/4th power reduction as one of the motors will only reduce 1/6th power, which is within the band in case of rectifier isolation.

TM2 & Rectifier-2 of TC1

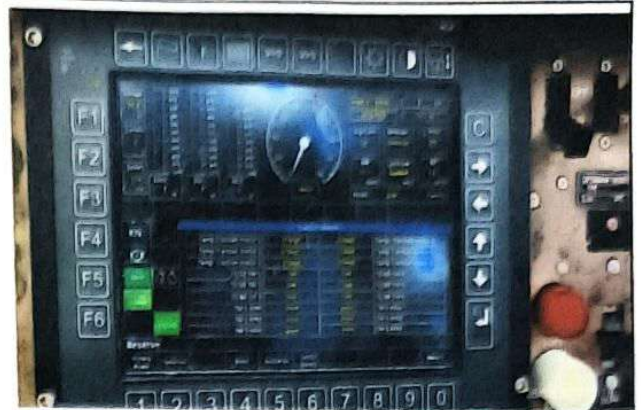
Node Progress

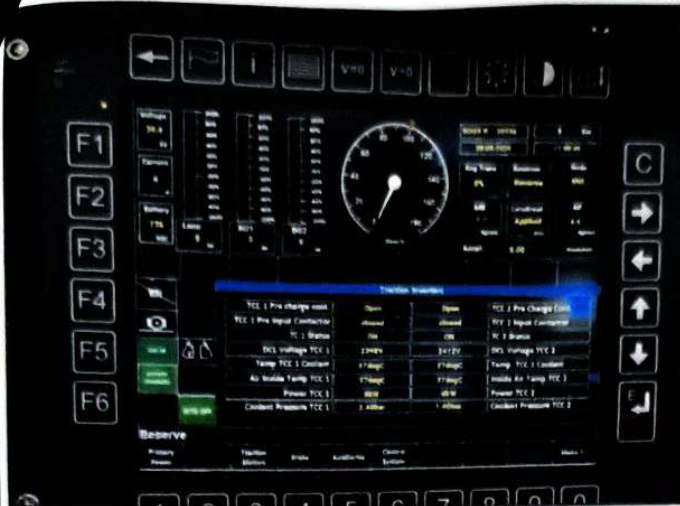
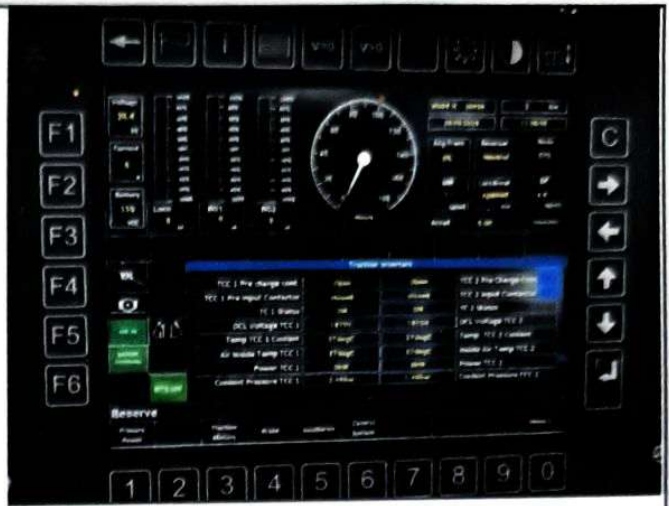
- 12) M/s SIEMENS intimated that pulsing sequence of BUR has been modified to address the issue being faced in ZRs. During testing at CLW no abnormal tripping of BUR is reported due to the pulsing sequence. However it was observed that DC link Voltage was building only after throwing throttle which is above 590 Node so the issue of DC link voltage charging at 570 Node has been rectified. Thus, the efficacy of the same needs to be verified at ZRs

4QC Pulsing will Start in 590 Node
