Dated: 24.03.2025

Sub: Commissioning inspection of Loco No. 38856 equipped with M/S Hind Rectifiers limited make prototype IGBT based 3-phase drive Propulsion Equipment

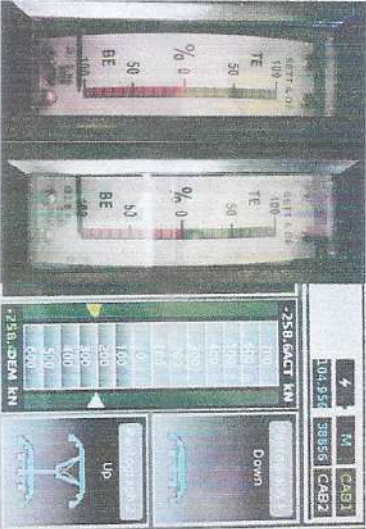
Actual BE electric	100% (= 10V)	Displayed value of BE on DDU should be changed according to Analog BE Gauge reading.	Checked in simulation mode In this condition at 596 node when regenerative braking was taken by moving throttle in BE side	258.6 KN BE, (130 KN per bogie) was observed. (also mapped with other values of BE Gauge reading)	Verified OK

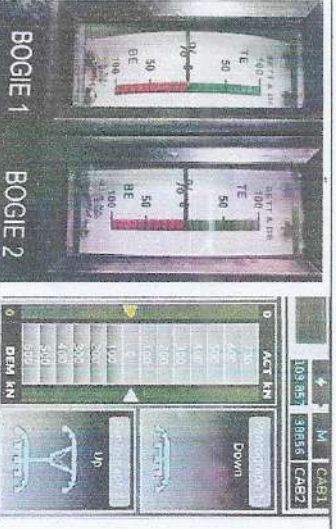
TE/BE at '0' position from both cab	Between 0% and 10% of Max KN	Observed values should be within prescribed range	0%	Verified OK

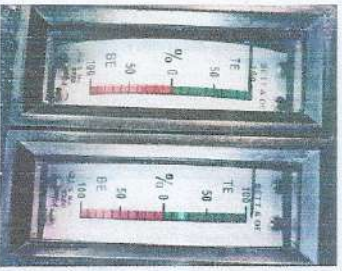
TE/BE at 'TE maximal'	Between 95% and 105% of Max KN	TE Calculated by formula =	100%	Verified OK

position from both cab		(actual TE of both bogie x 100) /504kN	(504kN value is observed in simulation mode.)

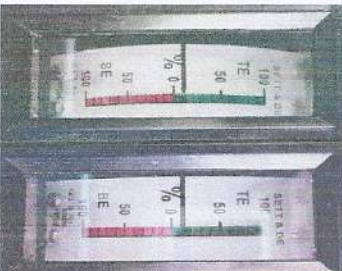
TE/BE at 'TE minimal' position from both cab	Between 10% and 33% of Max kN		10.8% (54.9 kN observed in simulation mode)	Verified OK

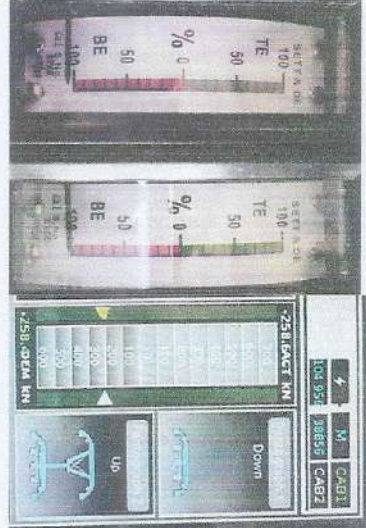
TE/BE at 'BE maximal' position from both cab	Between 95% and 105% of Max KN		99.5% (258.7 KN observed in simulation mode)	Verified OK

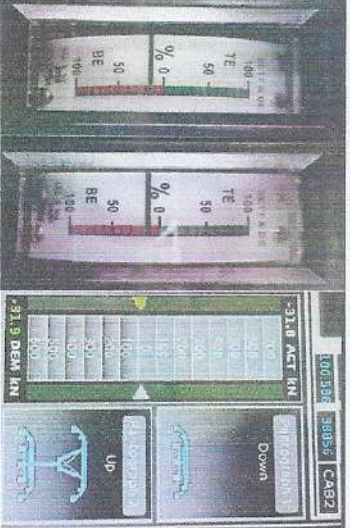
TE/BE at 'BE Minimal' position from both cab	Between 10% and 33% of Max KN		12.26% (31.9 KN observed in simulation mode)	Verified OK

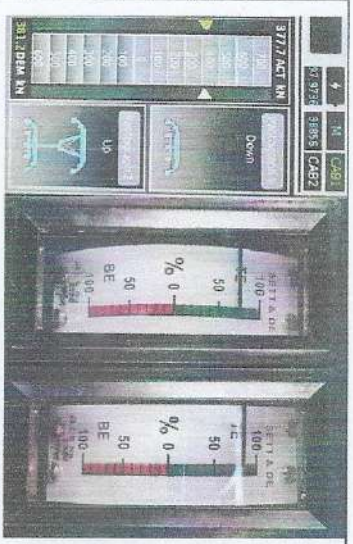
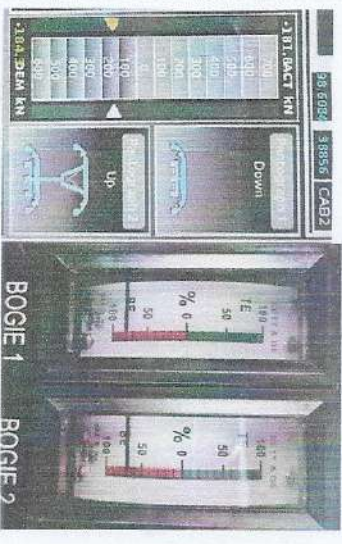
TE/BE at '2/3 position' in TE and BE mode in both cab	Between 51% and 75% of Max kN		75% of TE (381 kN observed in simulation mode) 71% of BE (184.3 kN observed in simulation mode)	Verified OK

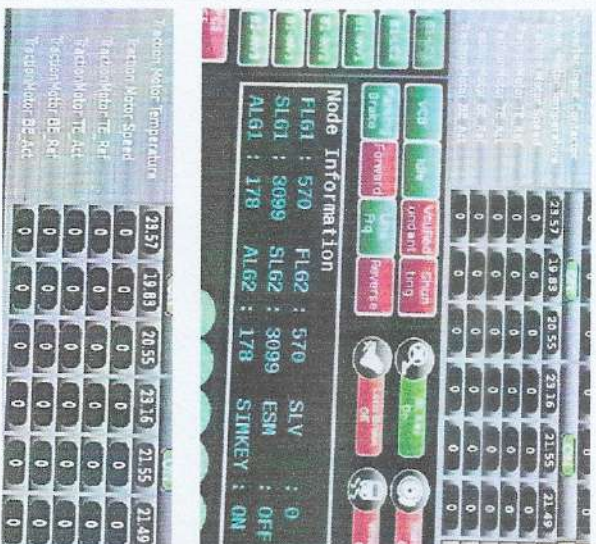
Both temperature sensor of TM1	Between 10% to 14.33% depending upon ambient	Observed values should be within	Checked in traction mode When loco was stand still at 570 node	Verified OK

temperature 0°C to 50°C	prescribed range	23.57 °C @ 23 °C amb

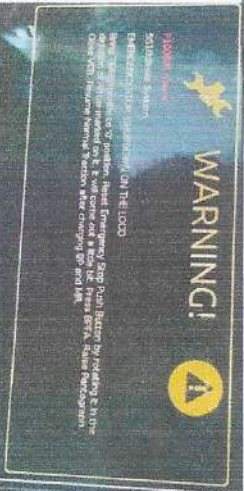
Test Function	Test Procedure/ Functional Requirement	Test Procedure Followed	Observation	Result	Photo
Emergency shutdown through emergency stop switch 244	An Emergency braking operation can be initiated by actuation of the Emergency stop push button on A panel VCB must open. Pantograph must lower. Flasher light should glow TE should be zero	Push Emergency Shutdown button located on A panel in both active and inactive CAB	<p>Checked for both in loco energized condition and in simulation mode</p> <ul style="list-style-type: none"> Push emergency stop button in loco running condition at 596 node VCB opened Panto lowered Traction effort became zero BP pressure dropped BC applied In inactive CAB emergency stop button on A 	Verified OK

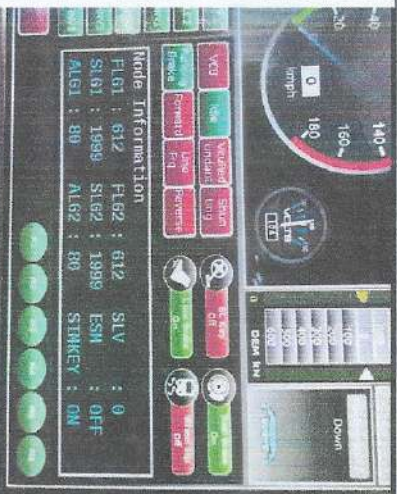
Test Function	Test Procedure/ Functional Requirement	Test Procedure Followed	Observation	Result	Photo
			<p>Moved BL key from D to off position and off to C and then moved from C to off position and removed at off position from A panel</p> <ul style="list-style-type: none"> VCB opened node reached to 550 Pantograph lowered node reached to 504 Main control electronics shut down

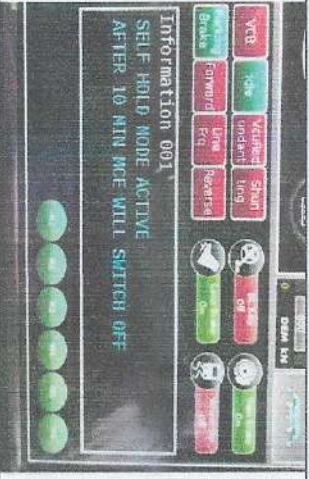
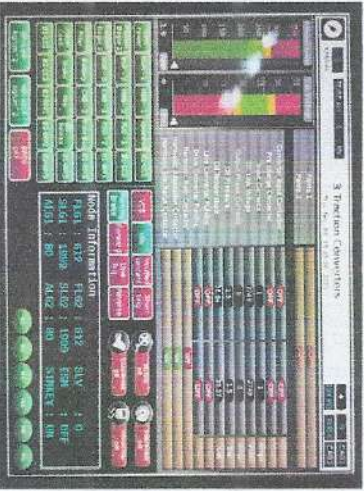
Test Function	Test Procedure/Functional Requirement	Test Procedure Followed	Observation	Result	Photo
Converter and filter contactor operation with both Power Converters during Start Up.	<p>FB contactor 8.41 is closed. By moving reverser handle or node ≥ 570(in case of M/s Siemens):</p> <ul style="list-style-type: none"> • Converter pre-charging contactor must close after few seconds. • Converter main contactor must close. 	DDU/HMI/Laptop was connected with VCU	<p>Checked in simulation mode from both CAB and Verified OK the status of contactor on DDU has been verified.</p> <p>After self-test when node reached to 504 then discharging contactor 8.41 was closed</p> <p>After closing VCB, when reverser was moved in reverse/forward direction at 570 node</p>	Verified OK

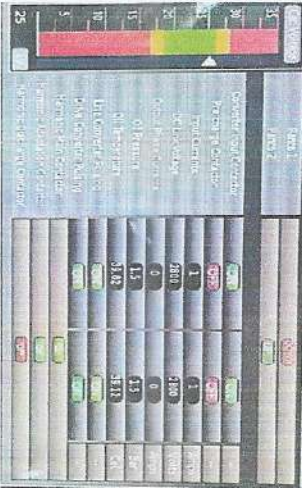
Test Function	Test Procedure/ Functional Requirement	Test Procedure Followed	Observation	Result	Photo
	<ul style="list-style-type: none"> • Converter pre-charging contactor must open. By increasing TE/BE throttle: <ul style="list-style-type: none"> • FB contactor 8.41 must open. • FB contactor 8.2 must close. • FB contactor 8.1 must close. 		<p>then Precharge contactor 12.1 was closed and DC link was charged</p> <p>After few second converter main contactor 12.2 was closed and and Precharge contactor was opened</p> <p>After moving throttle node reached to 596 and FB contactor 8.41 was opened and 8.2 and 8.1 was closed</p>

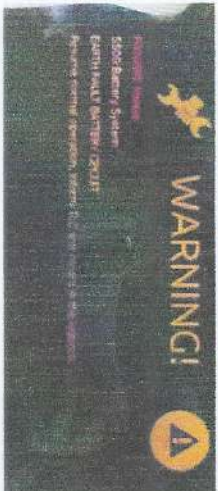
Test earth fault detection battery circuit positive & negative	wire 2050 to earth, create earth fault negative potential. <ul style="list-style-type: none"> message for earth fault By connecting wire 2095 to earth, create earth fault positive potential. message for earth fault. 	Wire 2050 is earthed to the body for simulating negative earth fault Wire 2095 is earthed to the body for simulating positive earth fault	Earth fault battery circuit pop-up message appeared on DDU screen	Verified OK

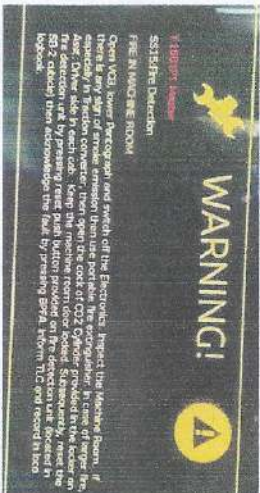
Test Function	Test Procedure/ Functional Requirement	Test Procedure Followed	Observation	Result	Photo
Angle Transmitter Failure Mode	Failure mode should work when difference between auxiliary contacts and the absolute value of angle transmitter became greater	Disconnect EA connector of angle transmitter from VCU	Checked in simulation and traction mode from Both CAB Disconnected EA connector from VCU 1 when CAB 1 was	Verified OK	At 0< TE< 1/3TEmax
Test fire system. Create a smoke in the machine room near the FDU. Watch for activation of alarm.	When smoke sensor-1 gets activated then • Alarm triggers and fault message priority 2 appears on screen. When both smoke sensor 1+2 gets activated then • A fault message priority 1 appears on screen and lamp LSF1 glow. • Start/Running interlock occurs and TE/BE becomes to 0.	for simulating this test smoke was created by burning a paper in machine room after setting a loco speed through throttle	Checked in simulation mode from Both CAB Alarm triggered and warning smoke in machine room priority 1 fault message appeared on DDU screen. TE became zero	Verified OK

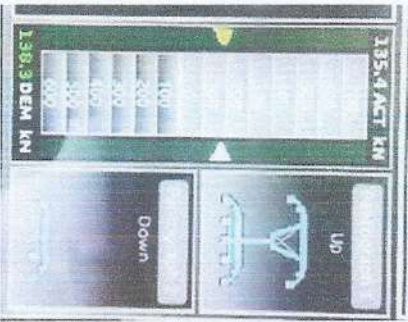
Test Function	Test Procedure/ Functional Requirement	Test Procedure Followed	Observation	Result	Photo
	<p>than 62% of the full range because of a defective master controller</p> <p>Pop-Up message Fault in angle transmitter should be appeared on DDU</p> <p>Activate failure mode by moving the rotary switch 152 to position '1'</p> <p>Move reverser in forward/reverse direction</p> <p>Take Traction</p> <p>Angle transmitter must work at 3 steps i.e 1/3, 2/3 and max. values</p>		<p>active at 504 node state</p> <p>Disconnected EA connector from VCU 2 when CAB 2 was active</p> <p>After taking traction node was reached to 596. A pop-up message fault in angle transmitter was appeared on both DDU 1 (when CAB 1 is active) & DDU 2 (when CAB 2 is active)</p> <p>Angle transmitter moved at 3 steps i.e 1/3, 2/3 and max. values</p> <ul style="list-style-type: none"> With application of throttle, gradual increase in TE

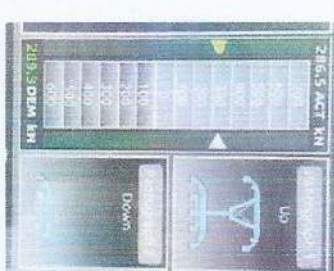
Test Function	Test Procedure/ Functional Requirement	Test Procedure Followed	Observation	Result	Photo
			<ul style="list-style-type: none"> has not observed Step change in values of TE/BE observed at position 1/3, 2/3, and maximum For TE minimal position from 0 to 1/3TEmax, TE observed is 138.3 KN For 1/3 TE_max up to 2/3 TE_max is 289.3 KN For 2/3TEmax up to full is 398.2KN <p>Regenerative braking in failure mode is working</p>		<p>At TE>2/3TEmax or TEmax</p>

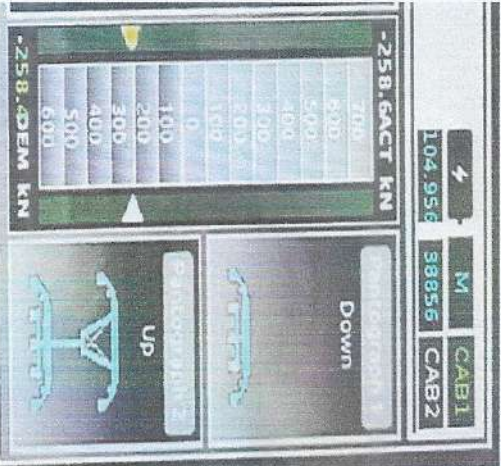
Test Function	Test Procedure/ Functional Requirement	Test Procedure Followed	Observation	Result	Photo
Bogie Cut Out Mode	Single bogie isolation;	Firstly, VCB opened then one by one Bogie 1 & 2 isolated	Checked in both traction and simulation mode from both CAB	Verified OK

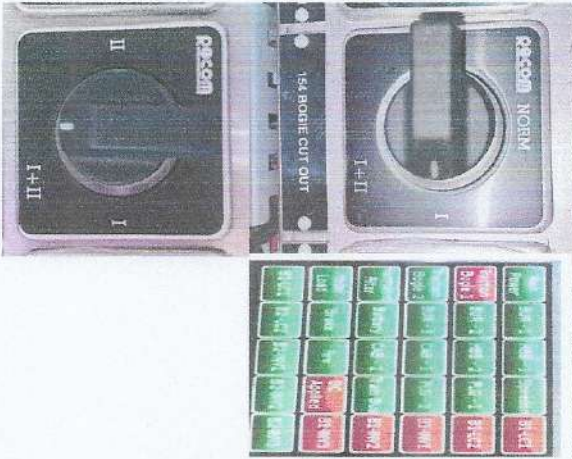
Test Function	Test Procedure/ Functional Requirement	Test Procedure Followed	Observation	Result	Photo
	Isolate any one bogie by rotary switch(154/SB1) to be kept in I/II(for isolation of SR1/SR2 position should be I/II) position and then isolation message should pop up on the DDU	through bogie cut out rotary switch For isolating SR1 through MCB, Firstly VCB opened then Tripped MCBs of SR1 127.1/1 & 127.11/1 in SB1 panel For isolating SR2 through MCB, Firstly VCB opened then Tripped MCBs of control electronics of SR2 127.1/2 & 127.11/2 in SB2 panel	After taking traction Priority 1 fault with Pop-Up message "Disturbance in converter" appeared on DDU LSFI and BPFA glowed in all cases After acknowledging BPFA faulty SR got isolated and LSFI lamp permanently glowed To do the faulty SR normal, MCE was reset.

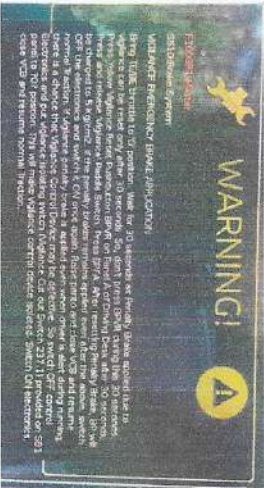
Test Function	Test Procedure/ Functional Requirement	Test Procedure Followed	Observation	Result	Photo
Vigilance Cut Out Mode	<p>Rotary Switch 237 to be kept at 0 position</p> <p>Speed to be increased and apply BPCS above 5kmph, no action to be taken for 1 minute</p> <p>VCD should not operate after 1 min</p> <p>Further rotary switch to be moved to original position '1' and check operation of VCD</p> <p>Pop up message of vigilance emergency applied should appear</p>	<p>When loco was in 504 node and SA9 was applied</p> <p>Moved VCD switch 237 located in SB 1 panel to 0 position</p>	<p>Checked in simulation mode from both CAB 1 and CAB 2</p> <p>At 590 node throttle was taken and node reached to 596. After 596 nodes, traction and speed appeared.</p> <p>When speed reached 11 KMPH BPCS push button was pressed and no action was taken for 1 minute.</p> <p>After 1-minute vigilance warning appeared.</p> <p>After 76 second vigilance emergency brakes were applied with popup on DDU.</p>	Verified OK

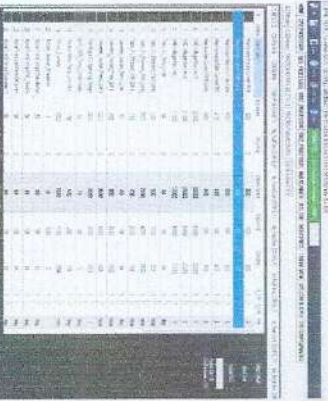
Description	Prescribed Value	Test Procedure Followed	Observation (Checked in Simulation/Traction Mode from Both CAB)	Remark	Photo
Auxiliary Current	Protective actions: 1) Maximum-current monitoring: $I \geq 400 \text{ A(RMS)}$: VCB off	For testing the protective action for the upper and lower limit of locomotive parameters Simulated forced signal was given to the controller of processor cards of the traction converter through software tool and GUI.	Values of Auxiliary Current at which VCB tripped To simulate the condition, the level has been changed in forced value. VCB tripped at IZ402A (Actual value – 117A Forced value - 100A Default value – 400A) Auxiliary winding overcurrent Pop up message appeared on DDU	Verified OK.

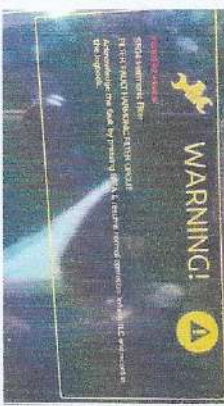
Earth Fault Filter Circuit	Protective actions: Binary signal 0 : normal operation Binary signal 1 : diagnostic data set (DDS) 'earth fault filter circuit'	To simulate this, in FB Cubicle, relay 89.6 A & B points are shorted.	Earth fault harmonic filter circuit Pop-Up message appeared on DDU. As per shed, the E/F indication need to be incorporated in DDU.	Verified OK

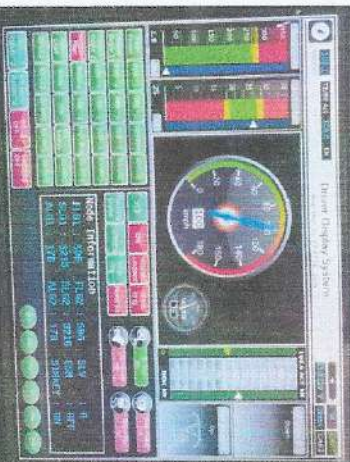
Description	Process followed to simulate the test	Observations	Result
Pressure Sensor Failure Test			
Speed restricted to 100 KMPH when harmonic filter got isolated	<p>Cas-1 In simulation mode, harmonic filter isolation has created by simulating the condition of harmonic filter over current by giving the forced command to the controller of processor card through software tool and HMI.</p> <p>Case-2 Harmonic filter isolated fault was created by harmonic filter contactor stuck off fault. By releasing pressure of EPC contactor (8.1 & 8.2) through FB cock on pneumatic panel</p>	<p>In simulation mode, for the first case, VCB was tripped and "Harmonic filter current too high" pop-up message appeared. After closing the VCB and taking traction speed was restricted to 100 kmph</p> <p>In second case, harmonic filter was isolated, again VCB closed and when traction taken speed restricted to 100 kmph.</p>

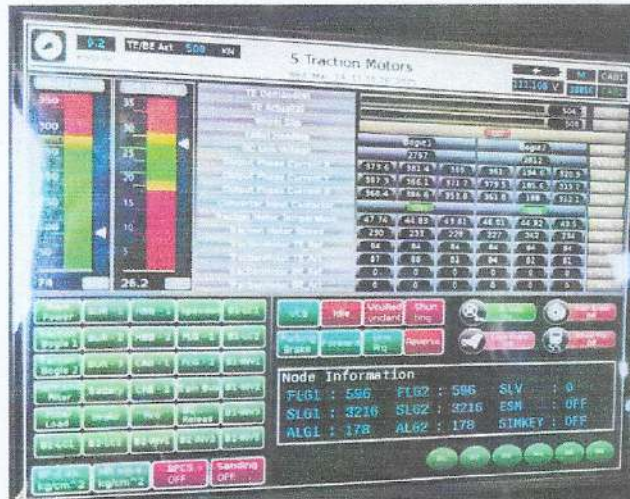
- a. On the day of testing it was fair and sunny and no rain was there.
 - b. In the up gradient the maximum tractive effort which was reached was 508kN and the maximum speed was 9.2kmph. Wheel Slip appeared sometime but no tripping of Traction converter had been observed.

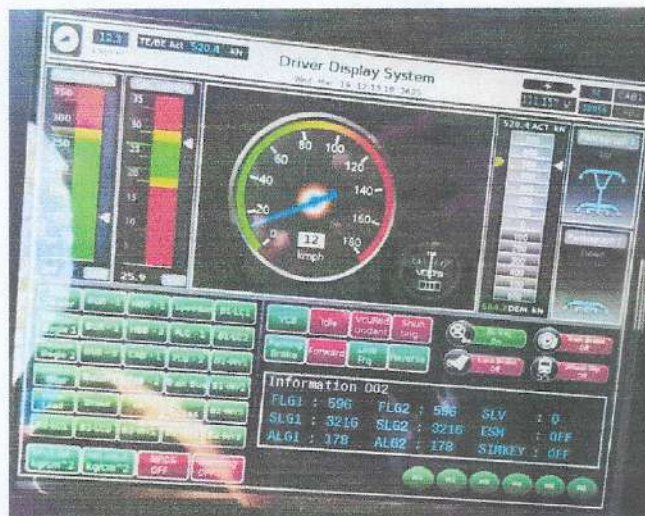
- c. In down gradient the maximum tractive effort which was reached was 520 KN and the maximum speed observed was 12 kmph. Wheel slip in down gradient was not observed and snapshot for the same is attached for reference.
