Distribution:	Document No.	WAG9-9K-EN5-RLN-13	
To all Team Leads and CCU System Engineers.	Issue Date.	11-Feb-2025	
	Format	Total Pages : 5 + Enclosures: 2	
		Document initiated by : Sudhanshu Jha	
		Initiating Department: RC-IN SMO RS EN 6	
		This supersedes : WAG9-9K-EN2-RLN-12

Release of CCU & TCU software.

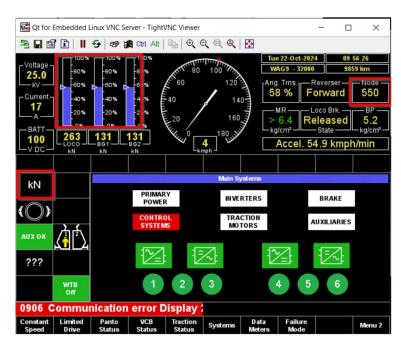
Conditions for Node increment from 550→560 Panto should be enabled and VCB ON command from operator should be enable during locomotive energization.

During testing it was observed this condition of node not increasing is occurring only when both pantos enable command 504→550 & VCB ON command 550→560 are initiated at same time. As the VCB ON command pulse will become zero after 2 sec's which is lesser than the Panto enable during only Locomotive energization time. For which the node remains at 550. How ever it doesn't impact on loco performance as the shown NODE no is only for display in SIEMENS propulsion.

Changes done to overcome this condition of panto enable has bee not considered from $550 \rightarrow 560$ Node increment.

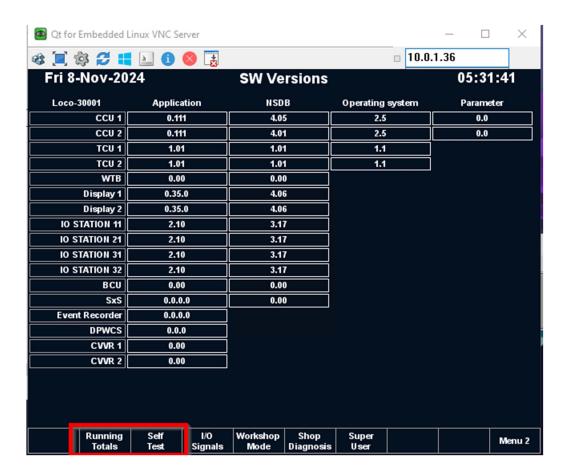
2) Loco Failed due to enabling the self-test mode reported from SCR/LGD: -

There were two failures reported from LGD/SCR regarding sudden pantograph lowering. On analysis of failure, it was observed from data that during the pantograph was lowered due to self-test enabling. As both Running totals and self-test activations are beside each other as shown below.

In new DDU software Location self-test function has been changed along with password protection enable.

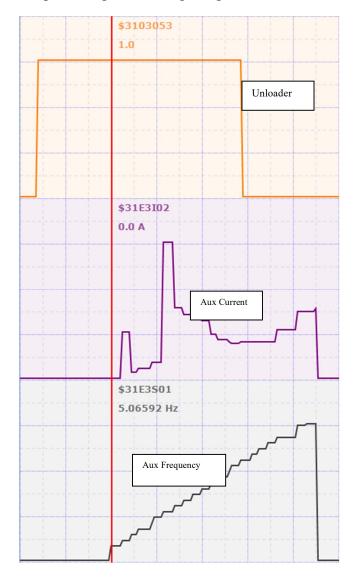
Unloader and Aux frequency

4) Compressor CB tripping Reported By BRC: -

The unloader valve command was released before the compressor but as there is additional delay in development of aux output when VCB is closed, this command is sustained for slightly longer period.

Due to the dynamic rise of aux frequency, unloader valve was getting closed earlier than the predefined time due to which the compressor current was rising because of the resistance offered by the compressed air in the tank. This sudden rise in current was disturbing the V/F ratio and the output voltage was also getting reduced.

The Above Scenario was taking place only if the time between VCB open to VCB close time is more than 20's. If the time is less than 20 sec from VCB open to VCB Close AUX will work on FAN Catch frequency mode in which frequency will not come to zero. To over come the changes done in CCU for operation of Compressor from min 20Hz if the time taken from VCB closer is more than 20'sec.
