CHANGE NOTE FOR SOFTWARE v30_xx_b07/v02_xx_b08		
	<b>6000HP 9 and 5 MODULE POWER CONVERTER</b>		
	<b>CODE: AA.58.V0.3021</b>	<b>EDITION: 30_xx_b08</b>	Pag. 4 of 33

## 2. OBJECT

This document summarizes the purpose and the new features of the Software Version 30\_xx\_b08<sup>2</sup> for the project 6000HP 9 Module Power Converter Locomotive and SW version 02\_xx\_b08 for the project 6000HP 5 Module Power Converter Locomotive. This is released as per the feedback from previous SW v29 of 9 Module Power Converter and SW v01 for 5 Module Power Converter.

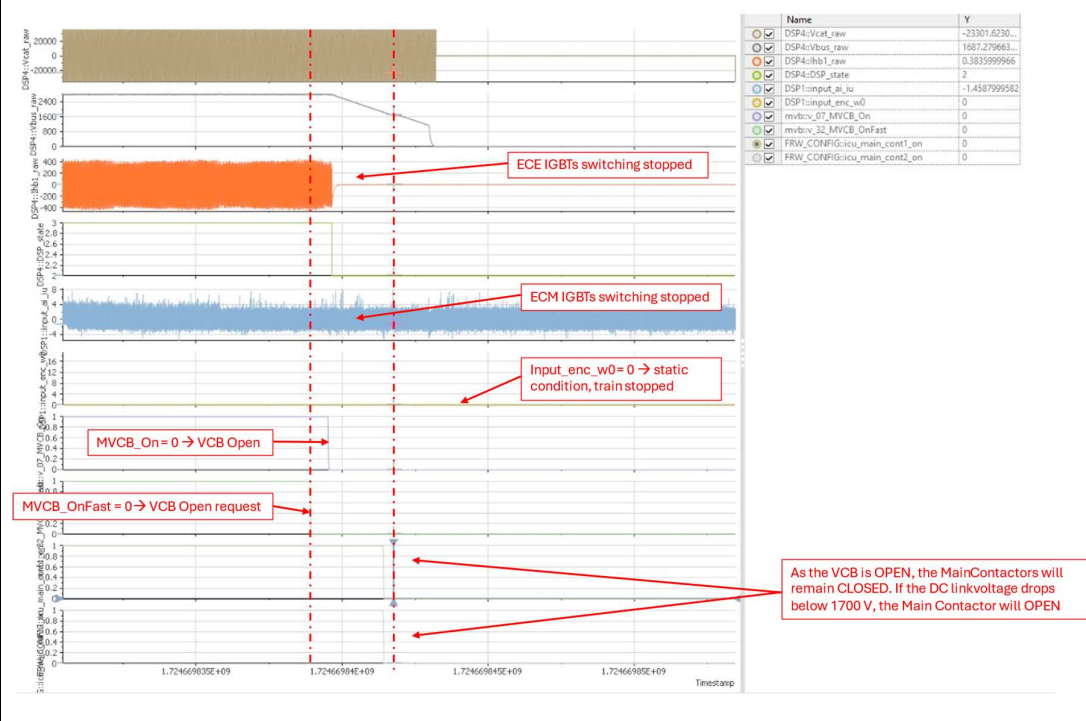
Neutral Zone management change

As a result of the validation of previous SW versions (29 and 30\_b04), customer and CG requested to implement the same logic that is implementing for Neutral Sections also when driver opens the VCB in static condition:

The behavior is evaluated in the HIL environment successfully:

The speed limitation of 1 m/s (3.6 km/h) is erased from the Neutral Section management logic so in both static and running conditions, as soon as the driver requested to open the VCB, the ECE and ECM IGBTs switching will stop, the contactors will REMAIN CLOSED, and the DC link will start discharging through the Permanent Discharge Resistor (RDP). If the DC link voltage drops below 1700 Vdc, the contactors will open to prevent high inrush current peak when the VCB is reconnected.

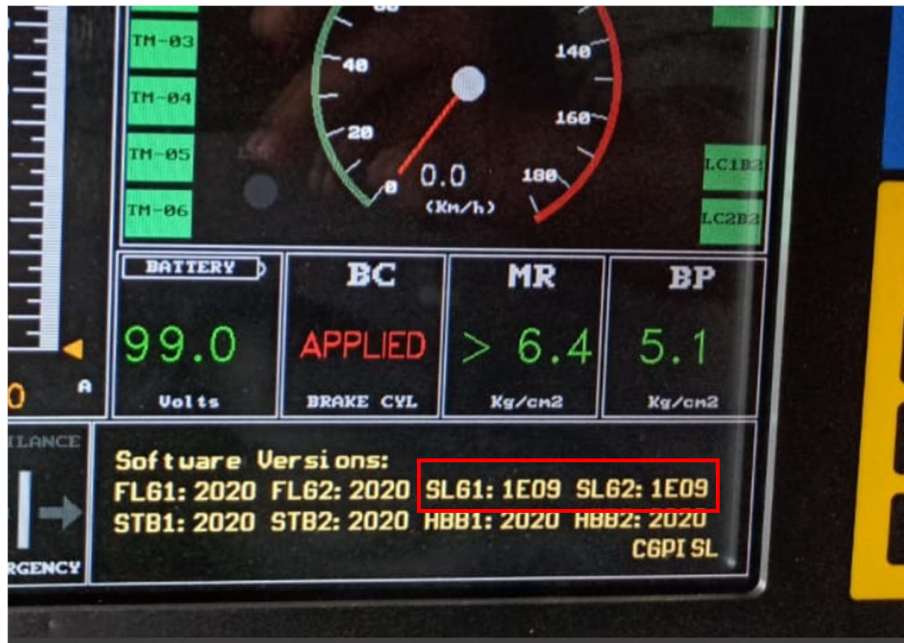
**3.8. SW v30\_xx\_b07 / v02\_xx\_b07<sup>3</sup>****SW Identification changed**

The same is tested in a WAG9 locomotive in Rourkela shed:

As per request of IR, the SW version identification has been changed to show clearly into the HMI the SW version uploaded as long as the Loco Type identification:

As per the new identification format, the major of the SW version (first two digits) will be used for SW version identification itself (v29, v30, v31, etc.), while the minor (last two digits) will be used for Locomotive Type identification (WAG9 = 09, WAP7=07 and WAP5=05).

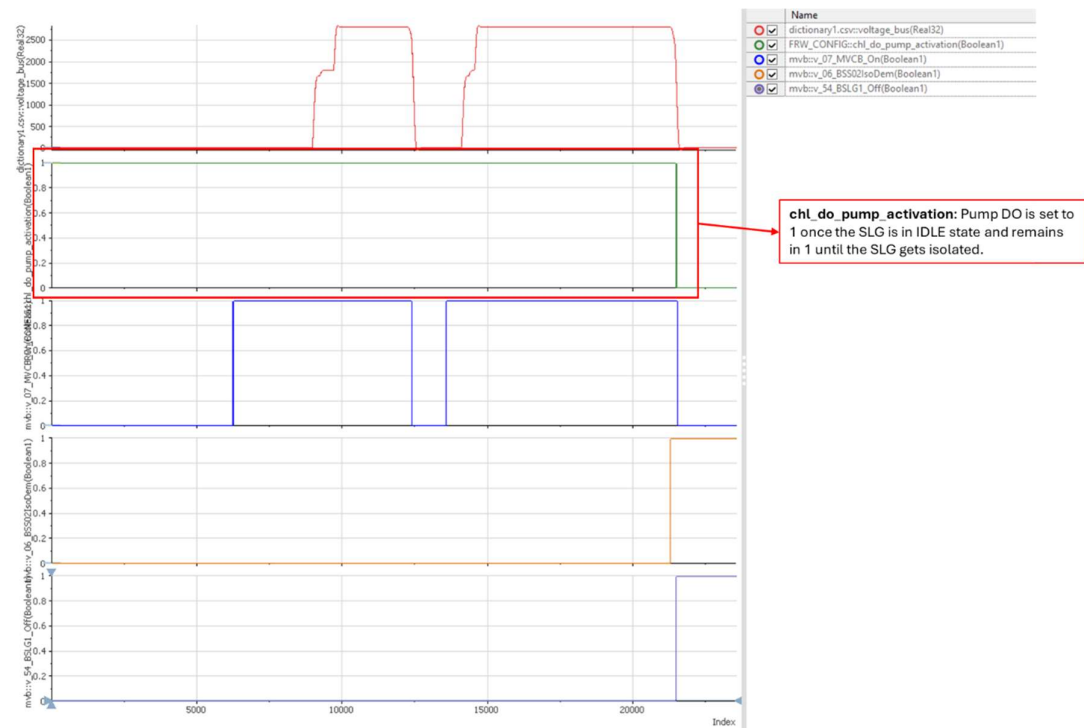
Converter Liquid Pump DO management

It is detected that with SW v29 the Converter Cooling System pump DO is commanded to switch ON and OFF every time the VCB is open/close. The multiple number of switches is generating stress to the cooling pump contactor that is leading to failures.

The same was evaluated in the HIL environment:

The pump DO command logic is change as per Royapuram shed's request:

- If SLG in IDLE state → Pump ON (FLG Node <504)
- If VCB Off → Pump ON
- If SLG Isolated → Pump OFF

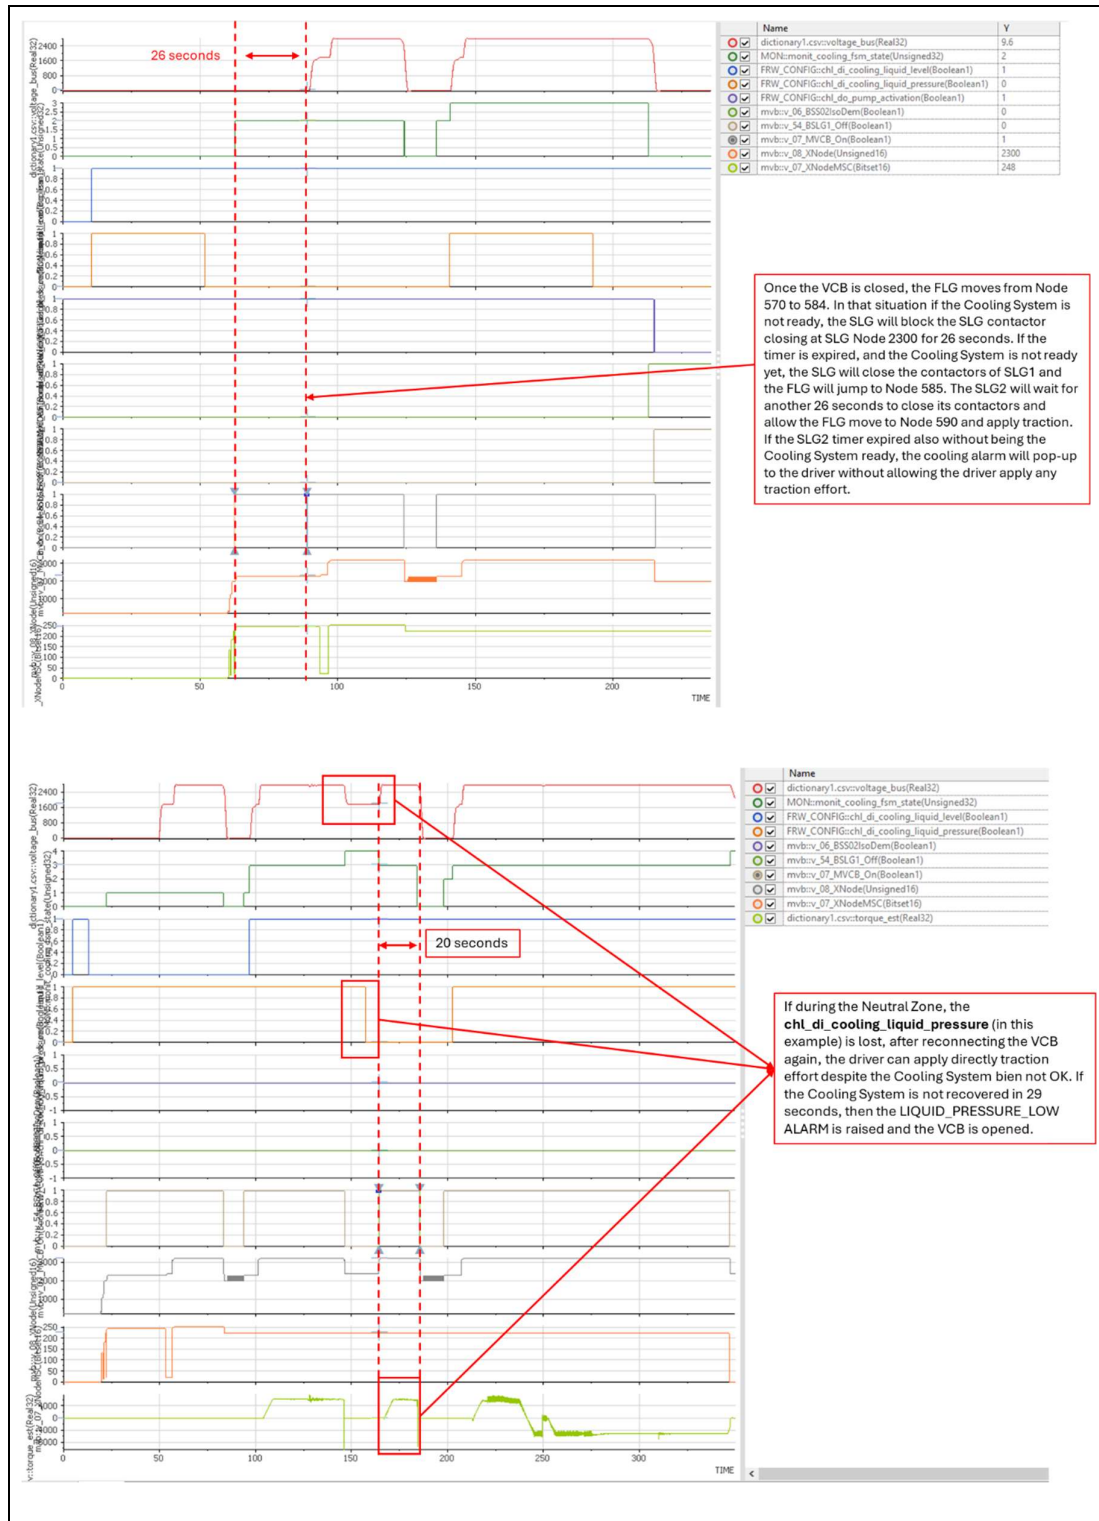
MOTOR ISOLATION due to Cooling Evaluator problems

In some sheds, it is detected that if the Cooling System is not ready and the driver moves the throttle to forward position (usually 9 seconds after the VCB is closed) to apply traction effort, the SLG is getting isolated due to ALL MOTORS ISOLATION alarm. Once the VCB is closed, if the Cooling System (Cooling level or Cooling pressure) is not ready, the alarm WARNING\_COOLING\_SYSTEM\_NOT\_READY is active in Traction Logs. Being the alarm active, if the FLG commands to apply traction effort, the alarm ALL MOTORS ISOLATED is pop-up to the driver isolating the corresponding SLG.

The same was evaluated in the HIL environment:

The SLG contactor closed at FLG Node 584 (SLG1) and 585 (SLG2) has been conditioned to the Cooling System ready status. This means that if the Cooling System is not ready when the driver goes from Node 570 to 590, the SLG will block the contactor closing at Node 584/585 to prevent apply any traction effort in that situation.

To avoid the FLG alarm of Converter Contactor Timeout if the Cooling System is not becoming ready after the FLG commands the contactor closing in these nodes, a timer of 26 seconds is added also to the conditions as if the timer is expired but the Cooling System is not ready yet, the FLG could move to Node 585 without giving any error.

The same logic is implemented in node 584 (For SLG1) and Node 585 (for SLG2). With this, if the Cooling System is not ready in 52 seconds, the alarm of LIQUID\_PRESSURE\_LOW or LIQUID\_LEVEL\_LOW will rise before the driver can reach Node 590.

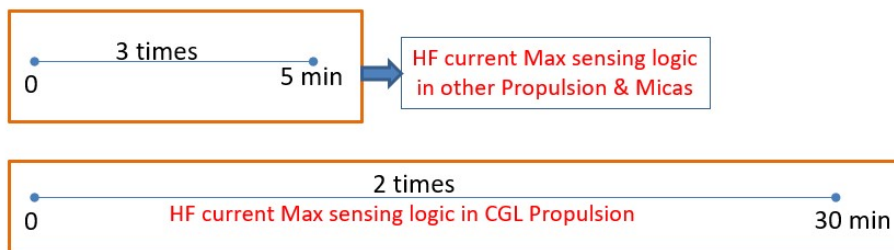
VCU data

SLG Isolation due to Harmonic Filter Overcurrent alarms

On Royapuram shed, it is detected that if the Harmonic Filter Overcurrent alarm is detected twice in less than 1800 seconds, then the corresponding SLG harmonic filter is isolated, and the speed is limited to 40 kmph. The activation of this alarm could be normal after raising the pantograph and/or closing the VCB due to magnetization current through the transformer winding or due to a high harmonic frequency component in the AC catenary.

**3. Harmonic filter isolation with filter current > Max**

- Harmonic filter isolation with Filter current greater than maximum is frequent in CGL. Firm is advised to solve this problem by adding a delay of 1 sec in detection of fault and by permitting the fault for 3 occurrences in 5 minutes(as implemented in BHEL/MEDHA locos). Additionally This harmonic filter counter to be reset every 5 minutes as per MICAS logic. CGL is yet to solve this issue.

The proposal is to change the alarm management so that if the alarm is detected three times in less than 5 minutes, then the harmonic filter would be isolated. This management could help to better differentiate a critical over current situation (real problem on the harmonic filter) to the non-critical sporadic events and increase the field availability.

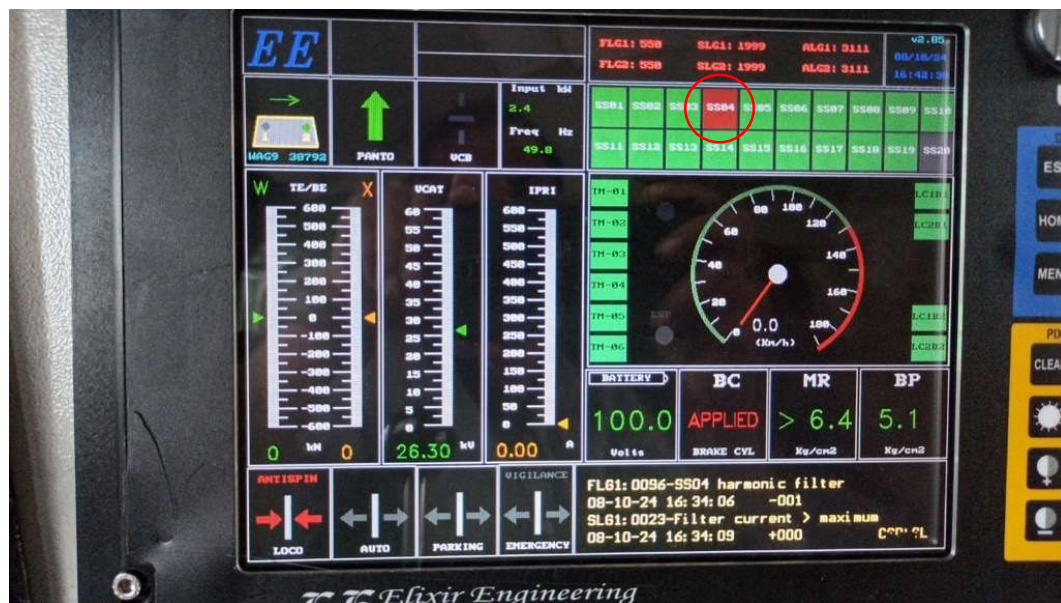
This behavior has been evaluated on field service at Rourkela shed:

The Harmonic Filter Overcurrent alarm management is changed.
