Subject: Approval of software package 1.4.1.2 for ATIL make propulsion system

Subject: Details of changes, incorporated in software package 1.4.1.2

IR Propulsion Set

Software Package Release Notes

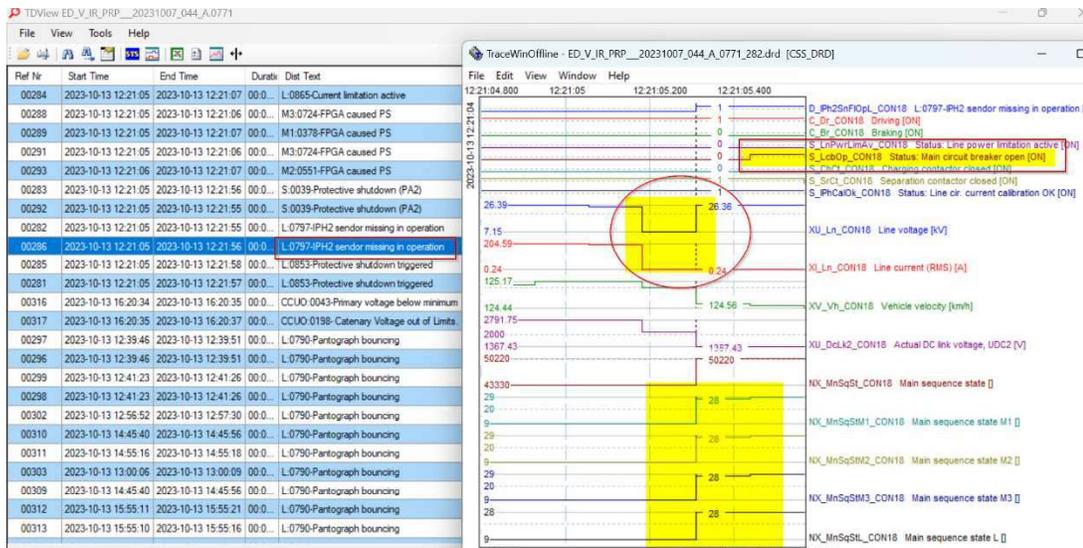
Problem Statement 2: When line voltage drop for short time then “ loss of IPH sensor message” being generated during traction and as a result of protective shutdown was initiated. This cause to open LCB and “Disturbacne in converter massage” pop up message is triggered on DDU

RCA: While troubleshooting we found issue could be related to supervision timings. We conclude that if line interruption is there, is only can cause for Protective blocking not protective shutdown , to improve this we are change Parameter related to line supervision from 500ms to 45ms which can give use correct response as per system requirements.

Solution : When the line voltage is suddenly dropped below Minimum Voltage 16.5 KV for more than 45ms , then protective blocking is initiated for line and motor converter and this will nullify the chances of with Disturbance in converter pop up message

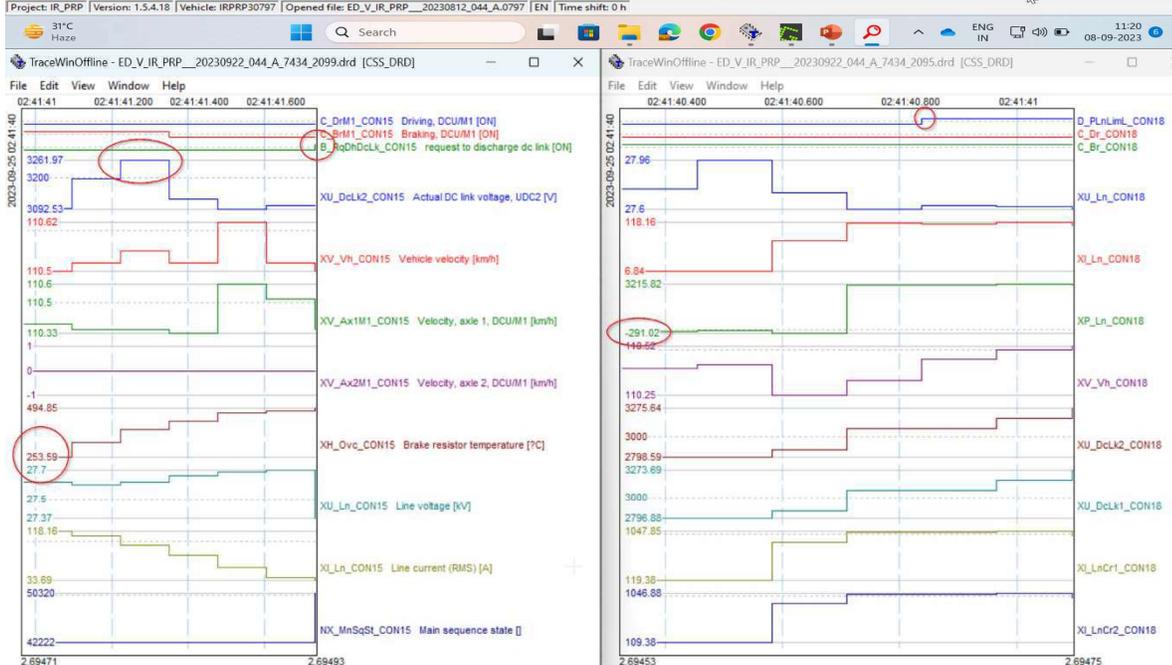
Problem Statement 3 : Traction converter isolation due to OVC temperature too high. DC link is getting higher is some special case , if it is higher then 3200Vdc Br-Rs chopper will fire and it can increase Brake resister temperature.

RCA: in several case study for OVP related issues most common thing we found is “It will happen only when Power limitation is active and Train is in braking mode”. During this time- DC link Voltage is getting higher than nominal operating condition and when it crosses 3200, OVP fires and Energy gets dissipated on OVP resistor.

Solution: Stabilization of DC link voltage through tuning of 4QC and implementation of power oscillation damping logic (POD)

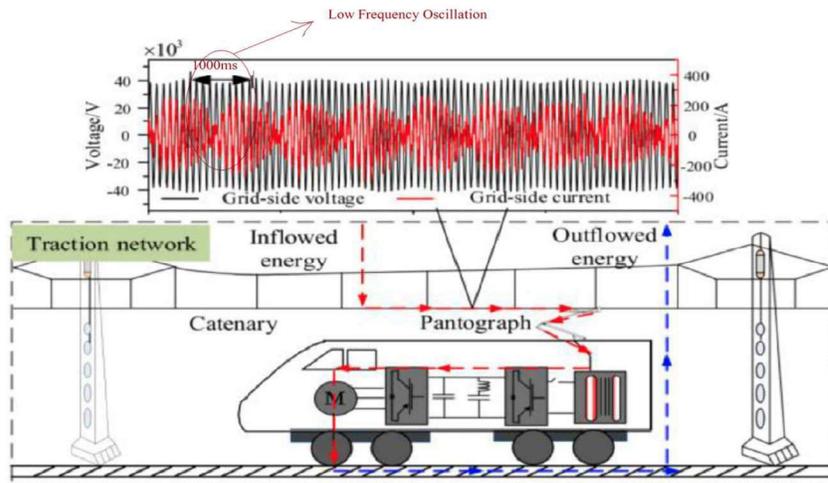
Problem Statement: While RCA for OVC related issue, we also found one more improvement will be introduced for DC link reference.

RCA: Low frequency oscillation on Line voltage could be effect the DC link voltage fluctuation .

Solution: Introduce POD function in addition to LPF to eliminate effect on DC link reference.
