SUB: Permission for uploading software version 30 (1E) in CGPISL make IGBT Traction Converter

Sub: Issues in CGL IGBT Traction Converters – Reg

8D Report

JIRA issue CLW – 874

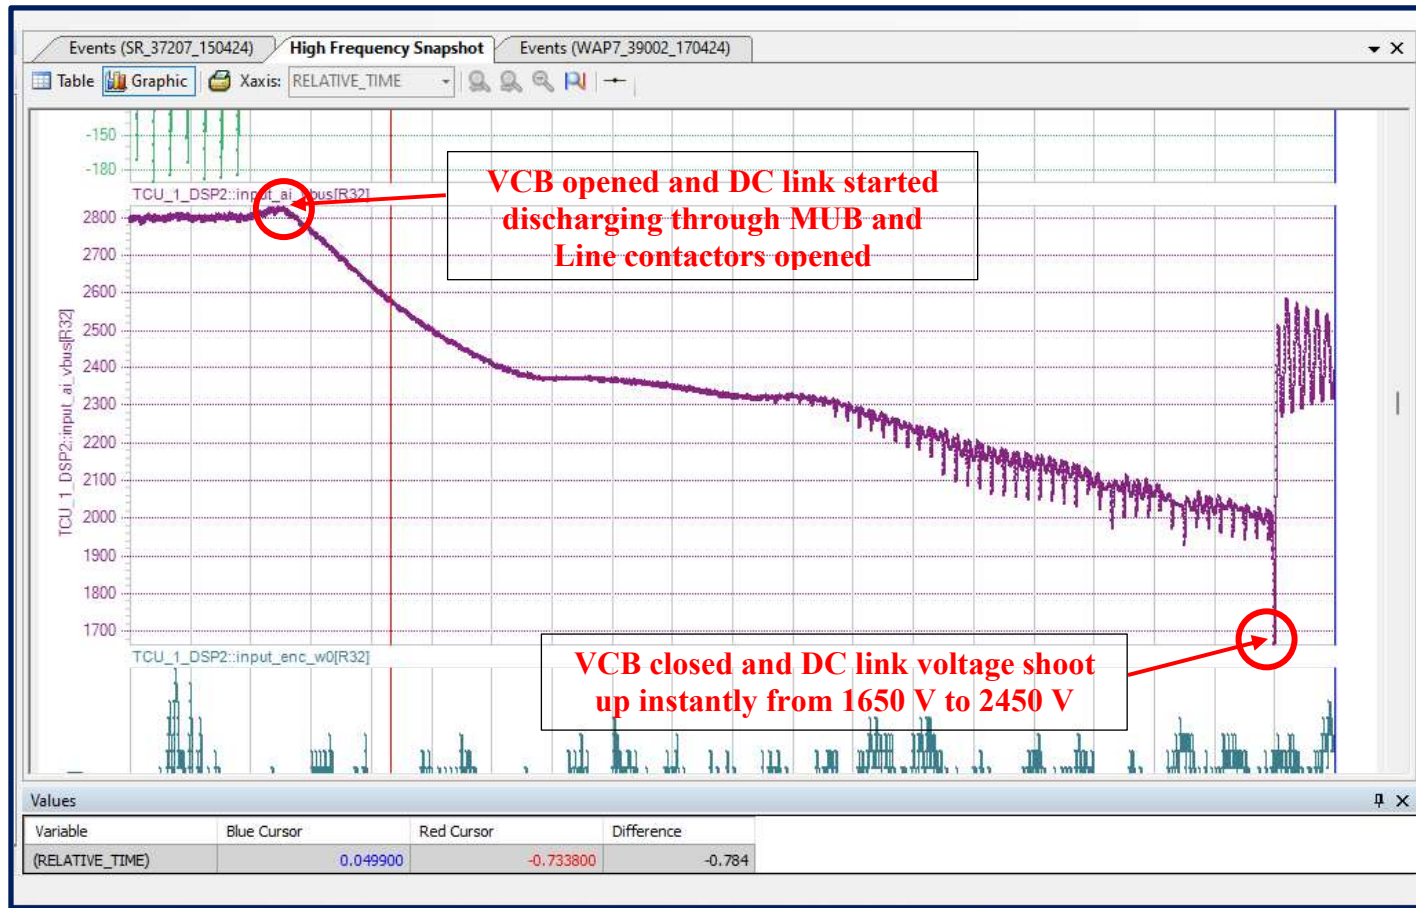
3. This is because in **CGL Traction Converter's (SR's)**, when every time VCB opens, **Line contactors get opened and DC link discharged through MUB resistor (Figure 1)**. When VCB is closed again, for immediate charging of DC link capacitor (since DC link voltage is too low) rectifier draws over current instantaneously (above 2400 A) and causing heavy inrush primary current (above 960 A). This has caused OCR action in the above failed locomotive.

Figure 1: DC-link voltage at the time of OCR action

From the above graphs it is inferred that DC link voltage is discharging after opening the VCB and pulsing of the rectifier H-bridge immediately after closing of the VCB in such a manner that drawing of inrush current by DC link capacitors (DC link voltage set value 2450 V – actual DC voltage at the instant of VCB closed 1650 V(Figure 1)). This sudden increase in the DC link voltage causes over current to flow in the rectifiers of both the Traction converters and hence the primary circuit. In MICAS and other propulsion DC link voltage is maintained and Line contactors remain in closed condition during VCB opening and DC link voltage will be discharged only at the time of protective shutdown.

Hence it is advised to analyse the above issue in the CGL IGBT SR and come up with suitable changes in the CGL SR software.

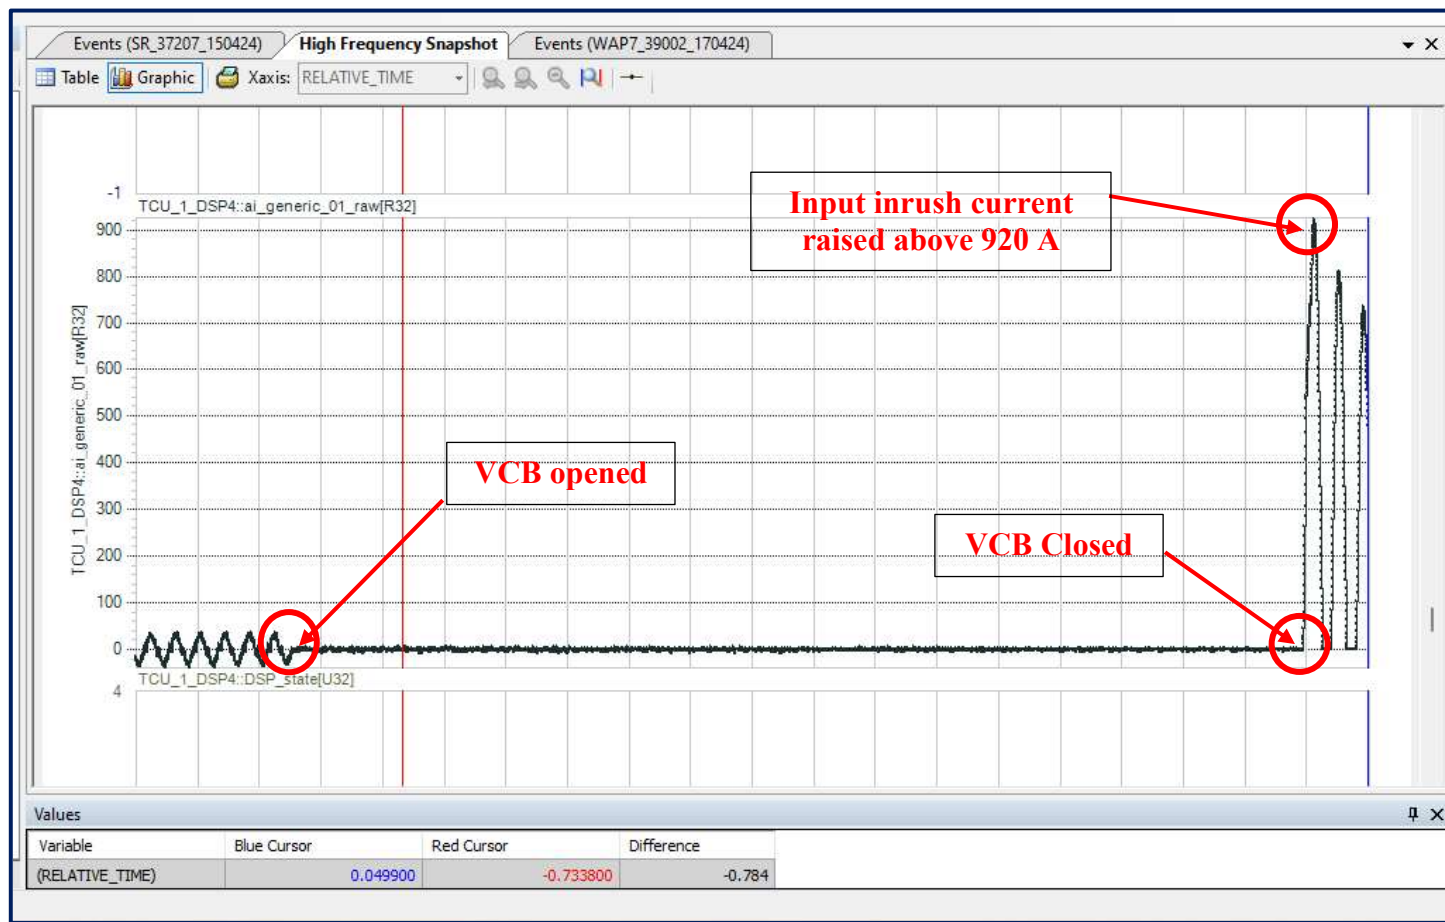
2. It is noticed that Rectifier Line 1 & 2 over current logged from both the SR's for several times during VCB reclosing time. As per SR data at the time of OCR action, input inrush current has gone beyond 960 A (Figure 2) and rectifier over current also logged (Figure 3).

Figure 2: Input Current at the time of OCR action

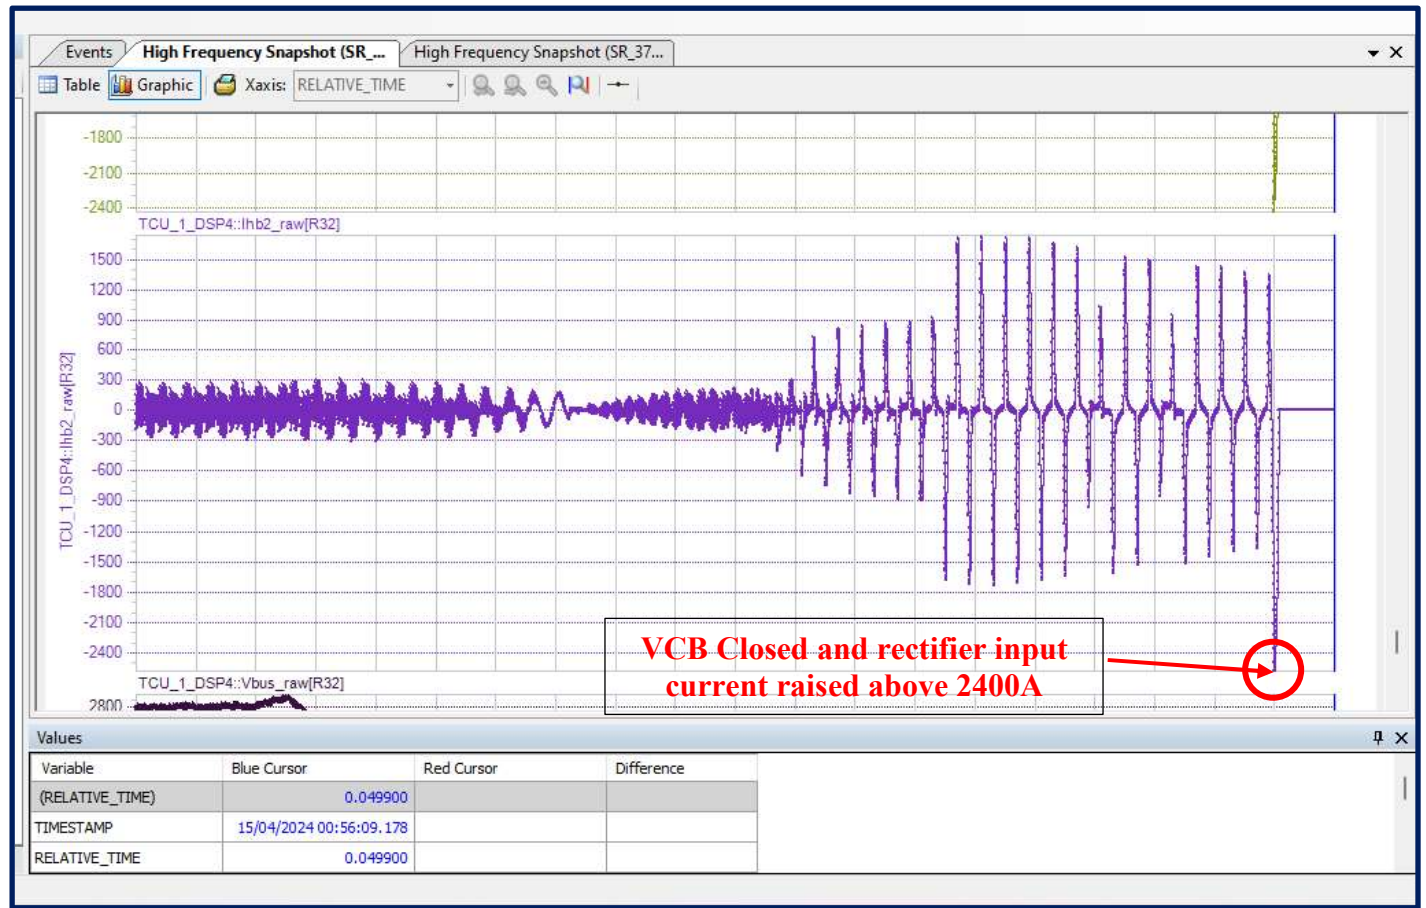
Figure 3: Rectifier Current at the time of OCR action

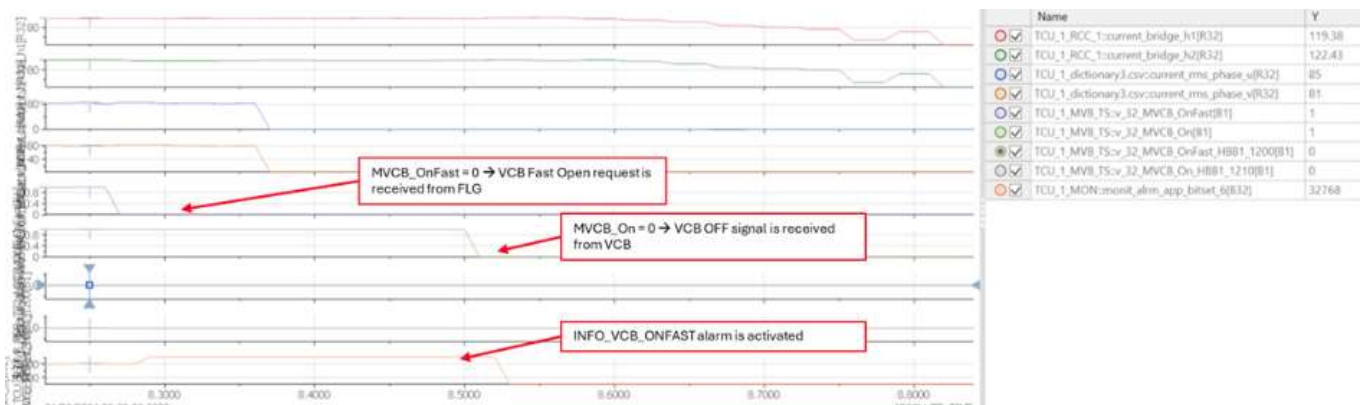
1. The SLG received from the FLG the MVCB_OnFast = 0 signal so a FastOpen request is sent to the SLG from the FLG.
2. After a few ms, the SLG received the confirmation from the FLG that the VCB was open (MVCB_On=0).
3. Despite of receiving the OnFast request and the confirmation from the FLG that the VCB was open.

Figure 1. Over Current LF SNS background.

4. When the FLG sent to the SLG a FastOpen request the SLG prepared itself to open the VCB and started stopping all the converters starting from the inverter.
5. After 1 second from the OnFast request, a catenary/rectifier input phase overcurrent situation happened. In that moment, the SLG (TCU) detects the over-current situation and protects as expected.

- In a noticed neutral zone, the switching management of the rectifier IGBT-s has been modified, stopping them as soon as the neutral zone signal is received.
- The SLG main contactor will remain closed until the DC-Link voltage drops below 1700V. In case of leaving the neutral zone before the voltage drops below 1700V, the SLG will be recovered by starting to switch with the main contactor still closed.
- If due to the neutral zone the DC-Link voltage drops below 1700V, the SLG will open contactors, completely discharging the DC-Link and requiring the normal bus charging sequence to be done.

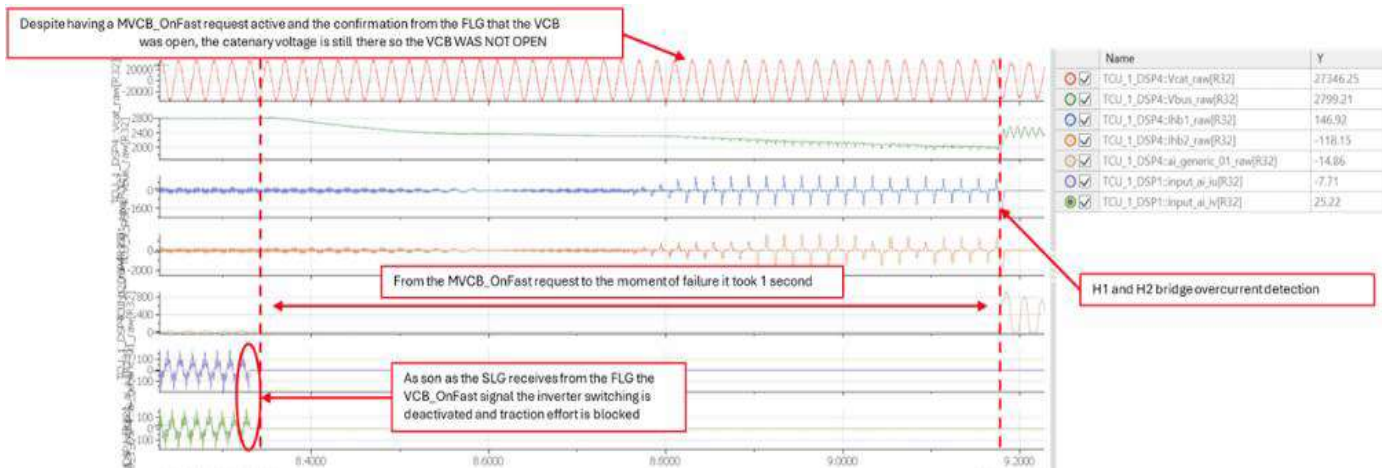
From the data obtained from the high frequency SNS of the SLG, it is observed that the catenary or OHL voltage does not drop at any time as it should in a neutral zone noticed by the driver. For this reason, the RCU IGBT-s are kept switching after VCB opening. Otherwise, the motor currents are switched off as soon as the opening signal is received from the driver.

The SLG contactors are kept closed, maintaining the DC-Link voltage which is still discharging by the permanent discharge resistors (safety protection).

1s after the neutral zone notice and the VCB closure, with no OHL loss, as the rectifier IGBT-s are still switching, the unexpected current peak and instantaneous loss of both SLG-s occurs, which are then able to recover and become operational again after a few seconds.

Figure 2. Over Current HF SNS background.
