**Sub:** Request to regular approval of final CCU software ver 2.06, TCU software 2.25 & ACU2.07 package as per below mentioned details to upload in all IGBT based propulsion system 6000HP (Leroy & Lutze IO module) WAG-9 / WAP-7 fitted locomotives.

Distribution:  To all Team Leads and CCU System Engineers.	Document No.	WAG9-9K-EN5-RLN-12
	Issue Date.	10-Jun-2024
	Format	Total Pages : 5 + Enclosures: 2 Document initiated by : SATYA PRAKASH. R Initiating Department : RC-IN SMO RS EN 5 This supersedes : WAG9-9K-EN2-RLN-11

Release of CCU & TCU software.

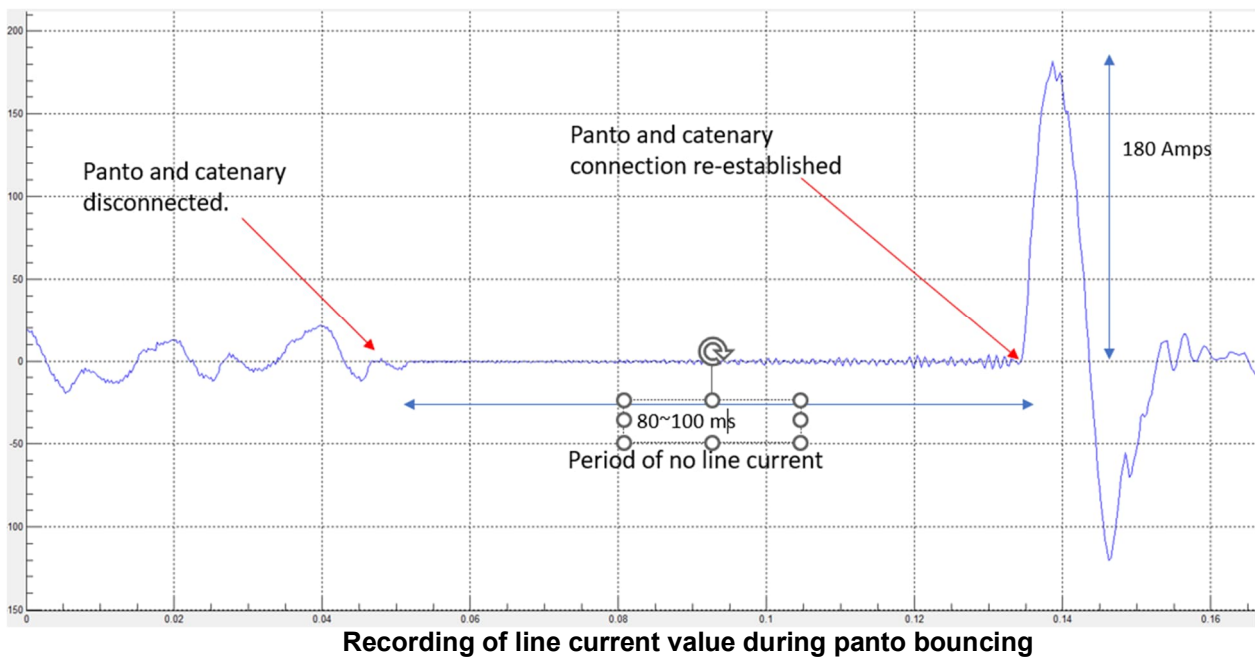
Based on fault code 81 reading of the 4QC, it was observed that there was incidence of panto bouncing during which line current goes to zero. This panto bouncing period lasts around 80 to 100 ms at high-speed operation.

When the contact between panto and Catenary disconnects, DC link voltage drops to approx. 2000V which increases the demand for more current. When the contact between panto and catenary is re-established, high inrush of line current is observed.

Peak of this line current can be seen in graph which is approximately 180 A. Thus, causing sudden rise in DC link voltage above 3100 Vdc.

This condition trigger's fault code 81 which signifies DC link overshoot above 3100 Vdc which results in opening of VCB.

Here, the period of line connection and disconnection is marked and observed time is around 80 to 100 ms. During this period, line current goes to 0.

- a) Voltage retention feature has been activated in both TCU and CCU software's. Voltage retention feature will be activated only when locomotive speed is above 30Km/hr and will be deactivated if the speed of locomotive is below 25Km/hr.
- b) PWI closed loop control error detection is now improved (DC 145) and related number of short pulse blockings is now removed.
- c) 4QC control is improved by Parameter by Smoothing time adjusted (10 ms => 0 ms) resulting in faster DC-link Control.

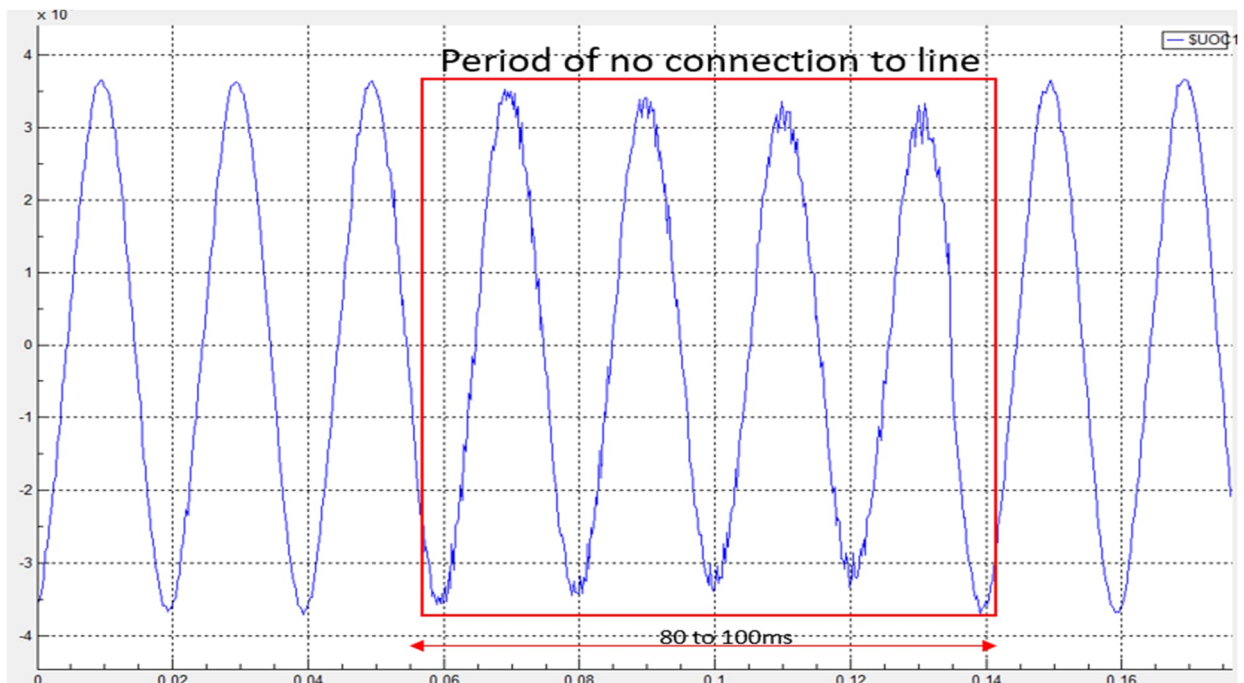
The voltage shown in the red box is not the actual line voltage but the apparent line voltage due to the continuous pulsing of 4QC.

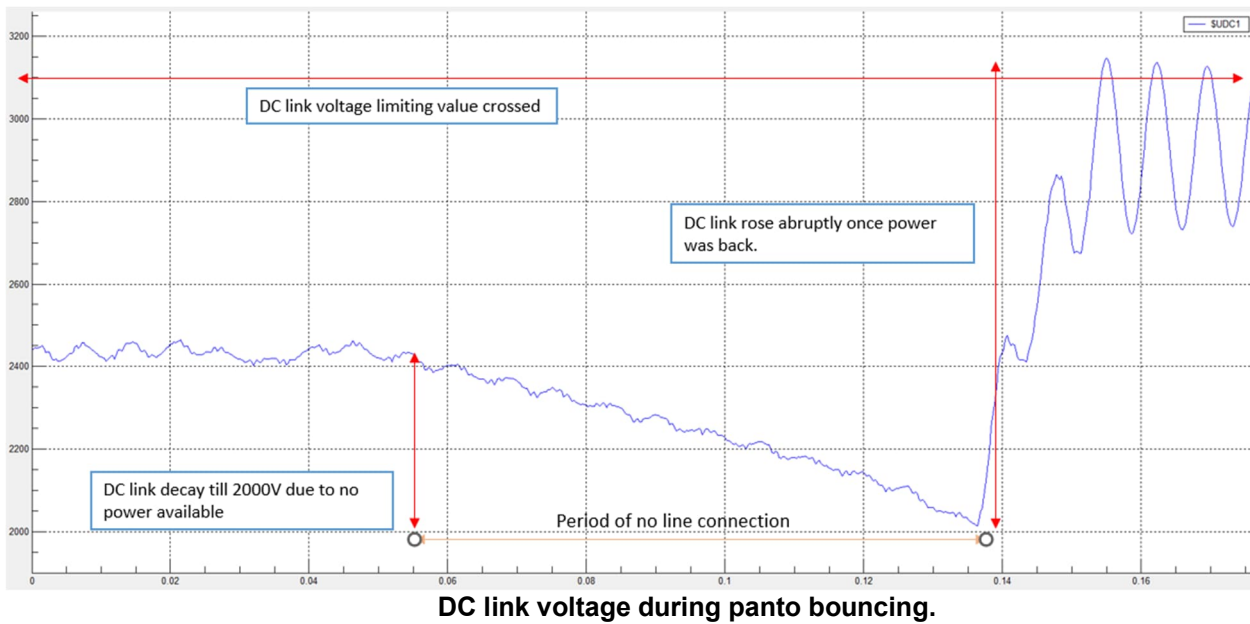
It can be seen from above graph, once the connection between panto and catenary was re-established, there is sudden rise in the DC link voltage observed.

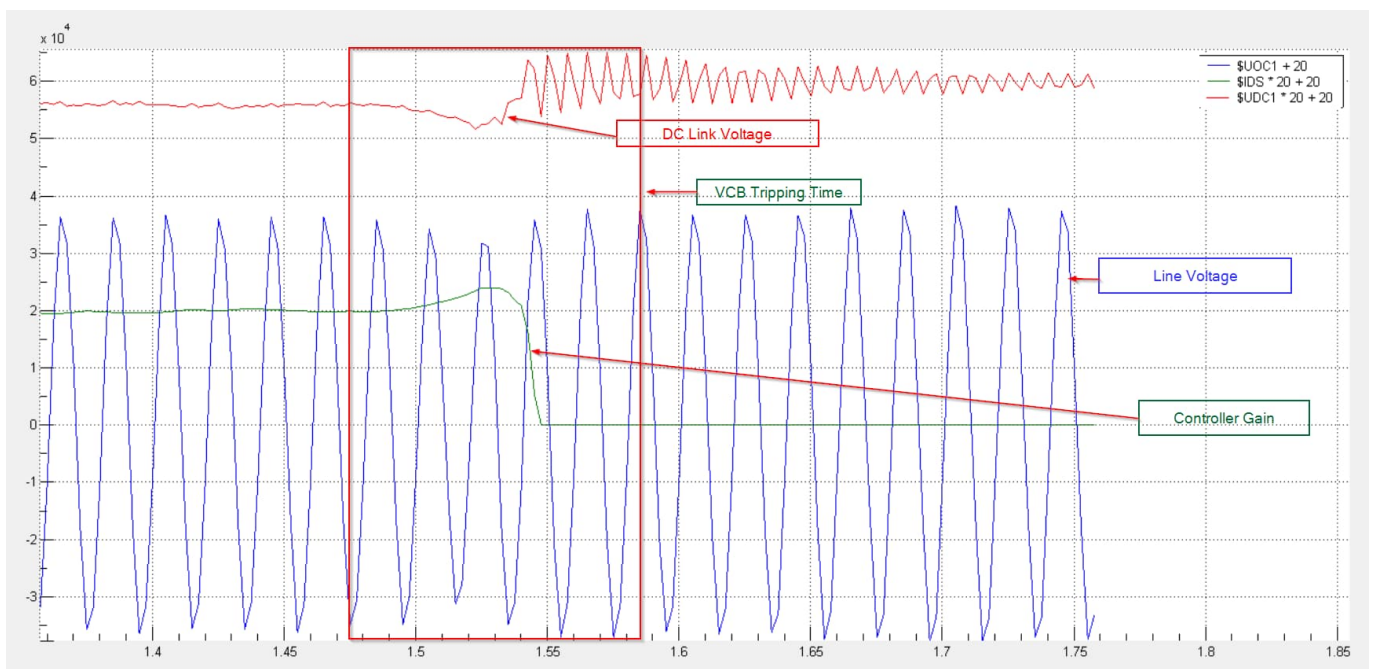
## b. Cause-2 Sudden Variation in Line Voltage :-

It can be seen from above graph, that line voltage variation which was causing increase in line current and tripping VCB and causing DC-Link voltage over shooting.

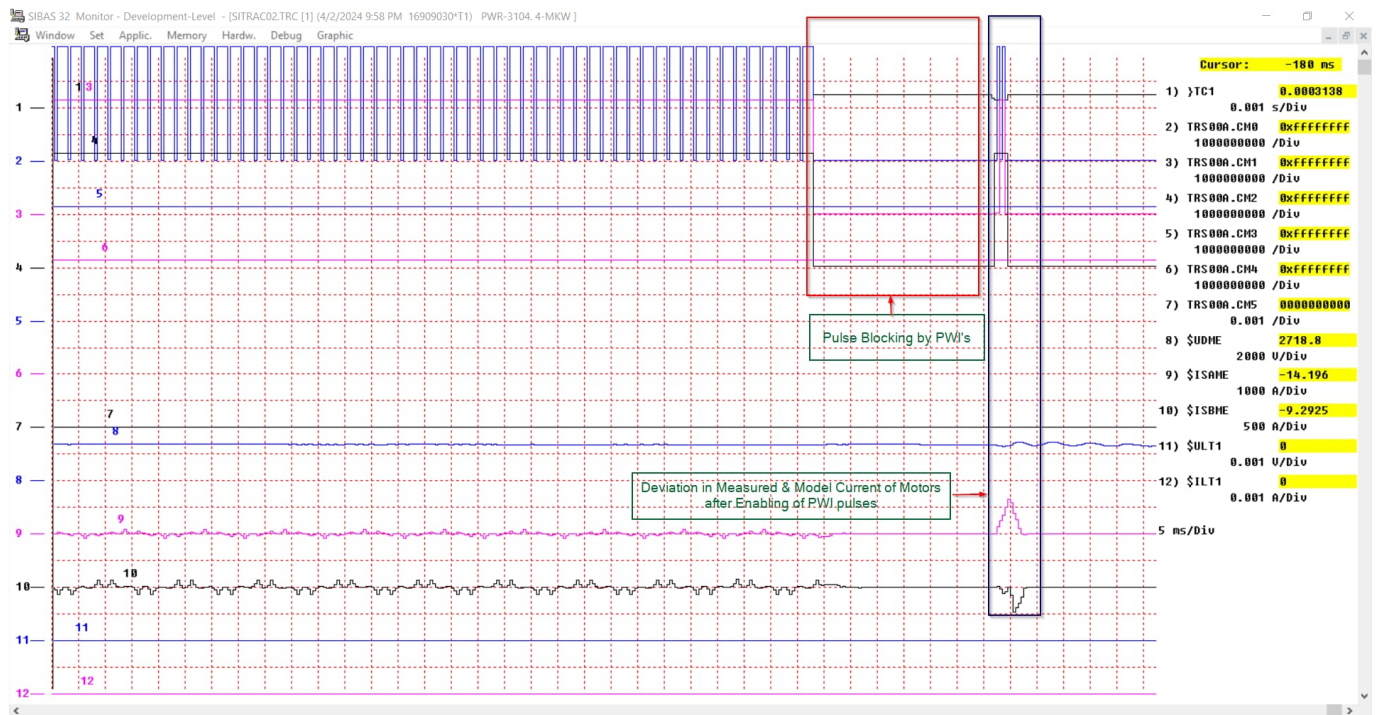
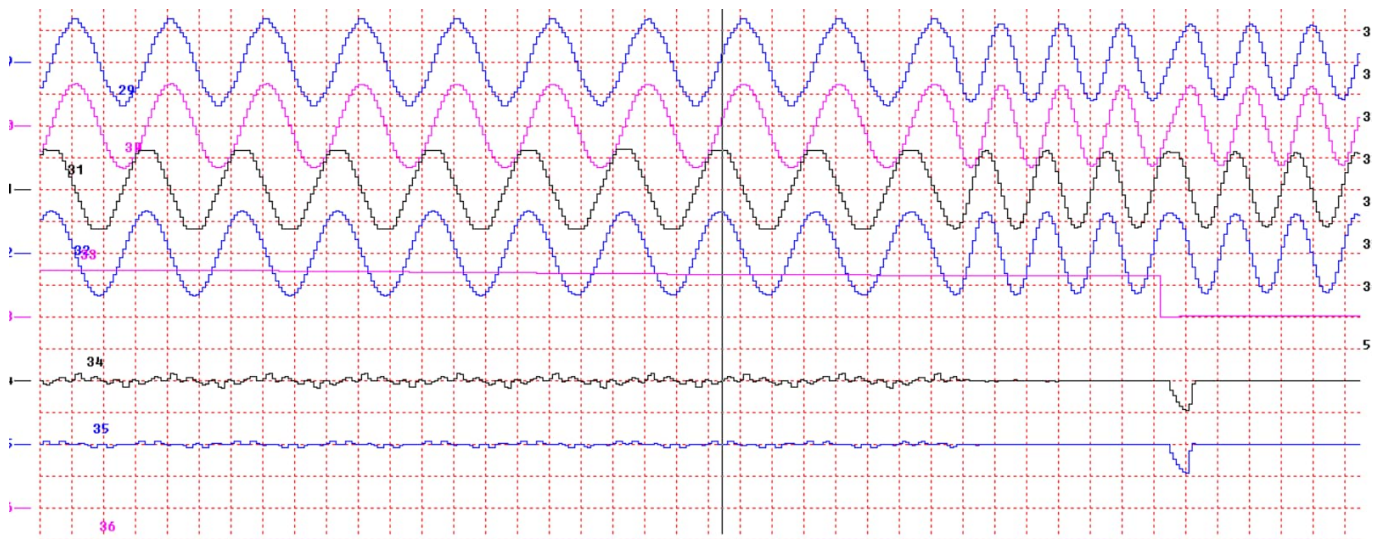
## c. Cause-3 asynchronization of PWI's & Motors : -

As shown in the above figures shows Pulse blocking phenomena which is causing the synchronization of motors and PWI (Signals 9,10) in first picture. Also Pulse pattern deviation in of PWI's in signal no 31 in second picture.
