This document summarizes purpose, new features of the Software Version: 53 for the Projects Bordline CC1500 AC 25kV M 2300 fitted in 1500 Amp IGBT Based Traction Converter equipped with PEC Trac Controller. This is the released version as per the feedback from previous Test Version 52.

Prepared	Sutanu Ganguly	24.03.2022	Project	CLW 3-Phase Locomotives	No of pages 8	
Reviewed	Tarun Jain	30.03.2022	Title	Change note for Software Ver-53		
Approved	Ramu S	30.03.2022	Converter	Bordline® CC1500 AC 25kV M2300 004 B01		
Department	MOTR		Document No.	Language	Rev.	Page

ABB India Ltd.			2UDB271271 ZAB 935	en	-	1

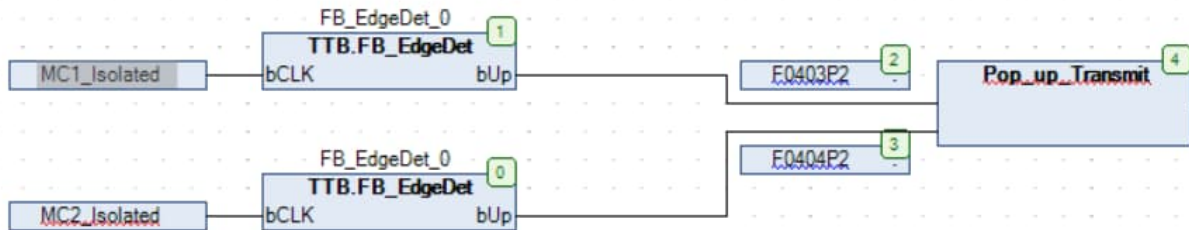
Non-Generation of motor pop-up in case one motor is already blocked by Speed Sensor Failure.

Problem: Secondary pop-up message suppressed during transmission as 1st pop-up bit remains high all the time.

Solution: Added Transmission with positive edge detection so that the transmission time for one pop-up is fixed and the subsequent next pop-up is not suppressed.

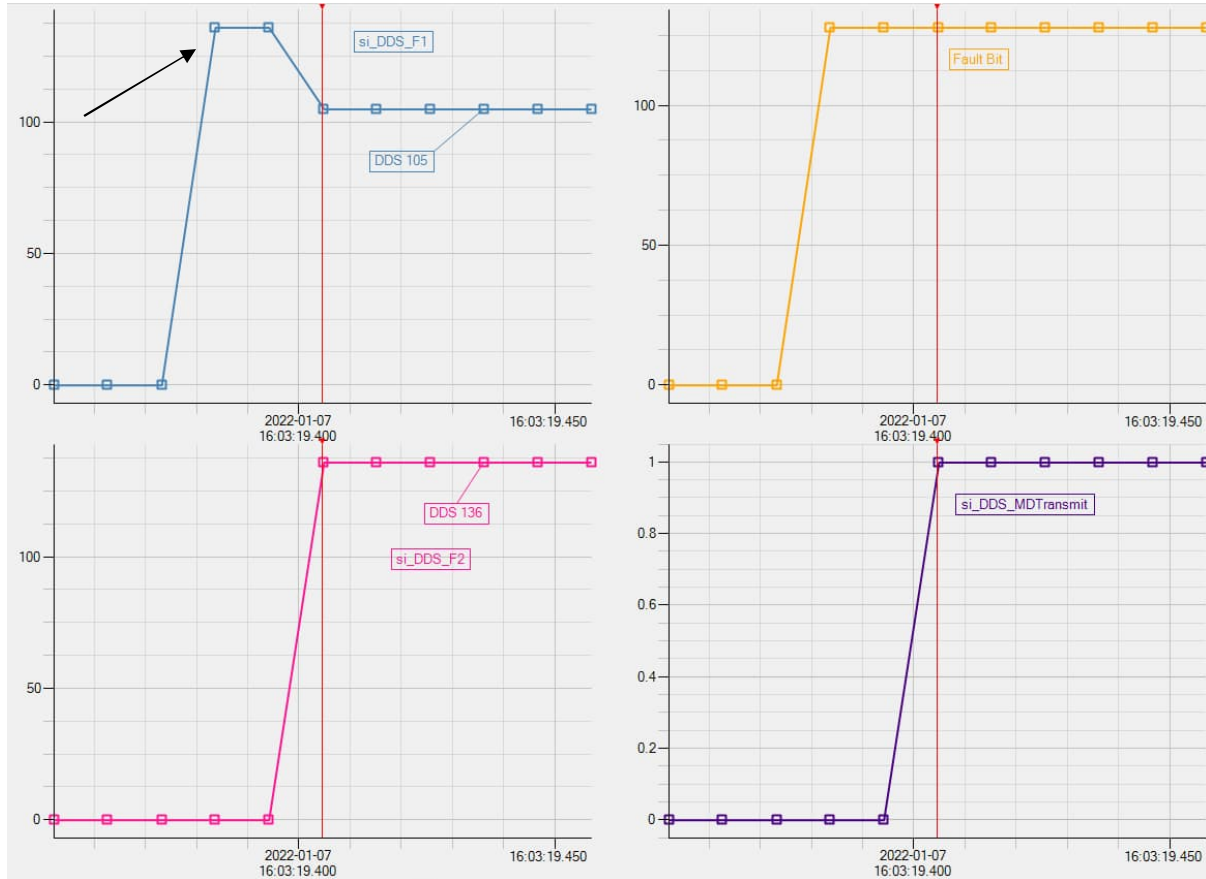
1. Interruption of secondary DDS Message during Fault Condition, wrong DDS Generation in some faults.

The DDS generation and Transmission was occurring at the same time, therefore some DDS Tasks were not transmitted. The Red line is placed in all the graph for better visual understanding. DDS considered below are SLG1:0105-Dist.temp sensor motor-1, SLG1:0136-TM1 Boggie-1 Isolated Also the F1 Fault was trying to generate 2 DDS at the same time which is not ideal and provides junk data.

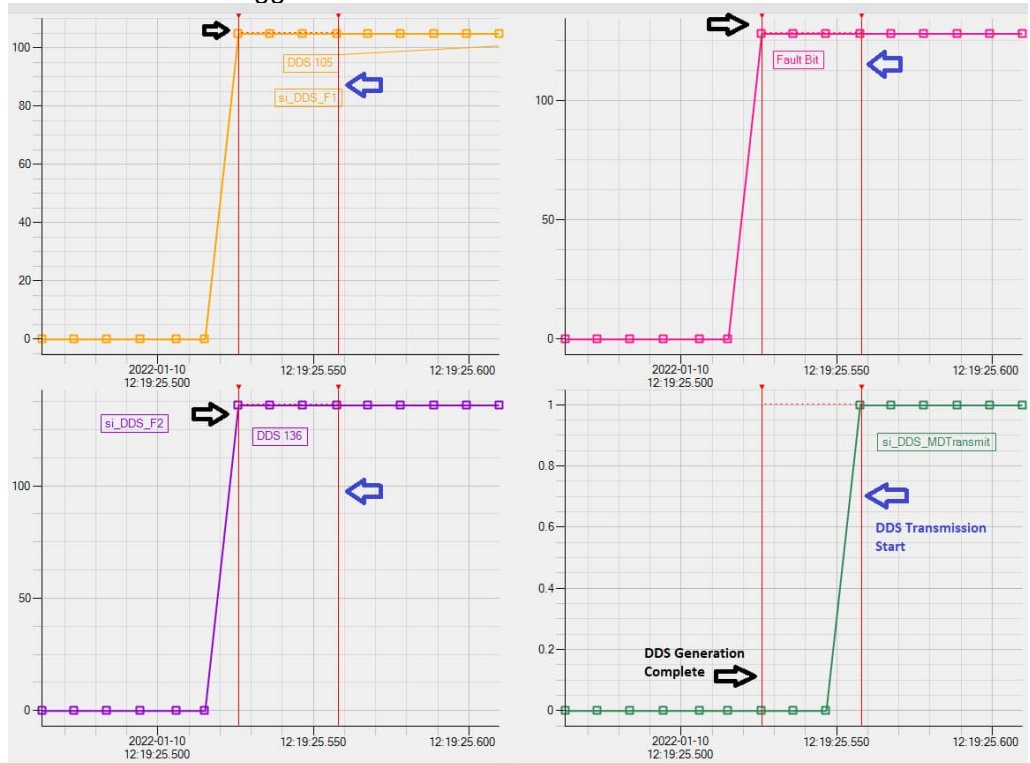
SLG1:0105-Dist.temp sensor motor-1

SLG1:0136-TM1 Boggie-1 Isolated

The Transmission task is delayed by 2 Tasks so that the Transmission can start after the DDS generation is complete. Also the DDS generation Fault Word is corrected to generate one fault message per word. Now we observe the correct generation and transmission. Similar issues were reported with DDS for UD_Failure, LC_isolation and speed_sensor_failure which will also be addressed by this update.

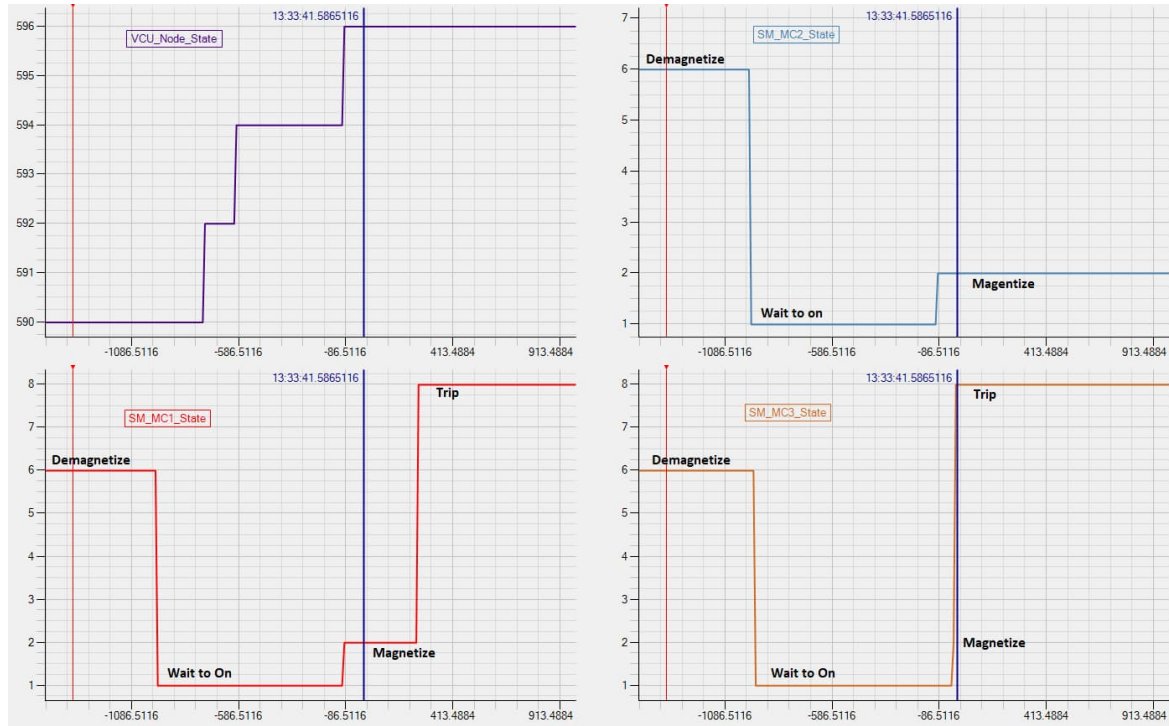
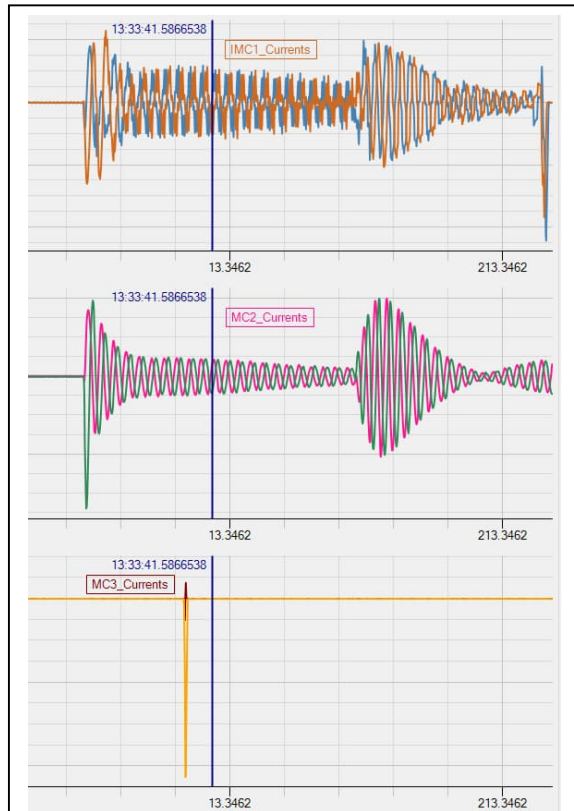
4 Cases of Mc Overcurrent reported which is analyzed. All Cases are reported at dynamic operation speeds. All cases show the trend of high magnetization current in the motors during pulsing when the motor completed a prior demagnetization cycle.

The MC1 goes into magnetization and remains in magnetization for approx 350msec and then trips with an over current.

MC2 shows a successful magnetization and it continues to pulse

MC3 trips instantaneously when it starts magnetization.

On Delay of 1.5 seconds introduced between successive demagnetization and magnetization cycle. This should improve the demagnetization of the motor and help to prevent the dynamic pulsing transients.

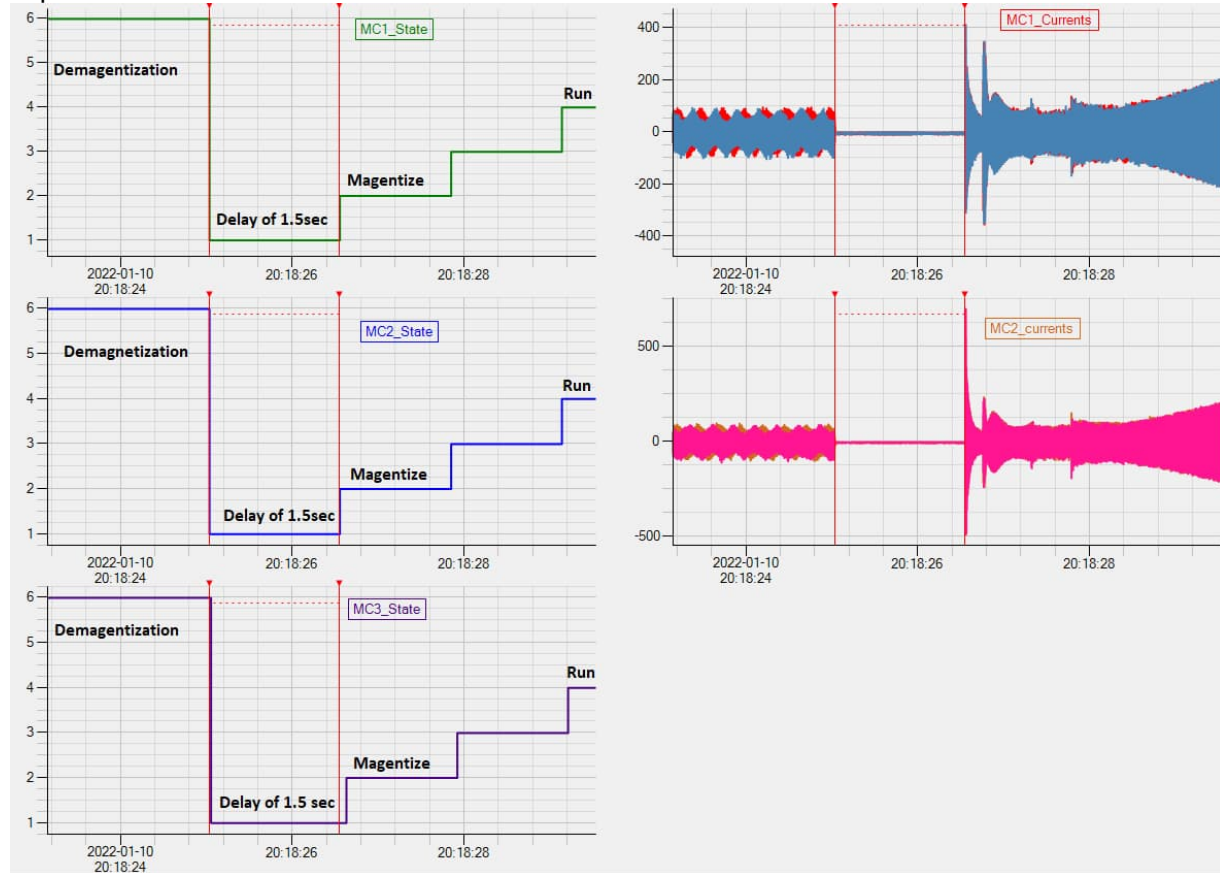
Below shows the testing result in Real Time Simulator with the new software and the implementation.

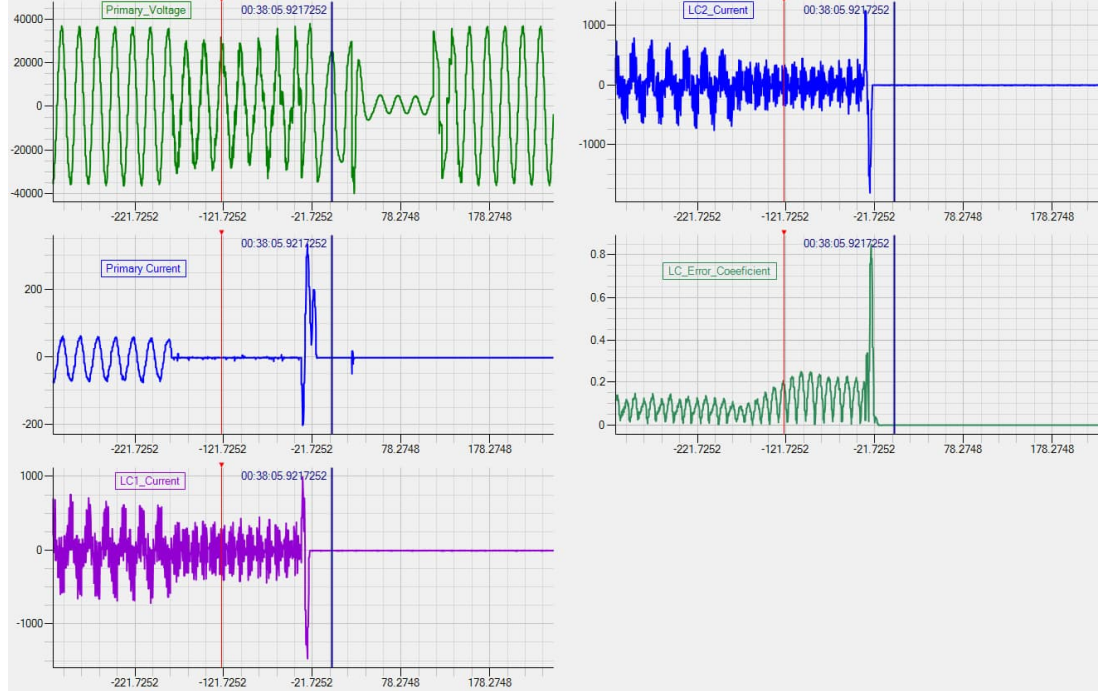
Problem: Non detection of pantobounce resulting in Line Converter pulsing and trip.

Introduction of additional monitoring of pantobounce considering Difference in P.U current for each Line Converter which if exceed 0.2.

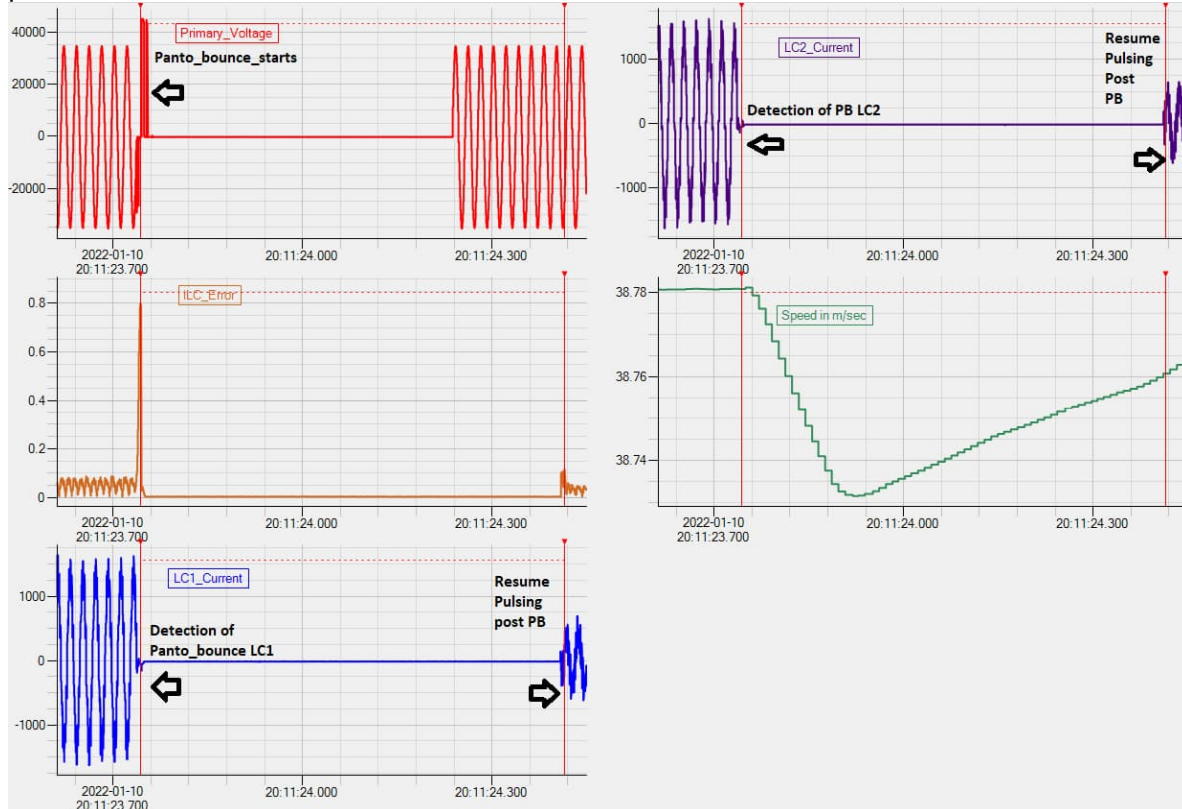
Below shows the testing result in the Real Time Simulator with the new software and different pantobounce conditions.
