Dated: 24.03.2025

Sub: Commissioning inspection of Loco No. 38856 equipped with M/S Hind Rectifiers limited make prototype IGBT based 3-phase drive Propulsion Equipment

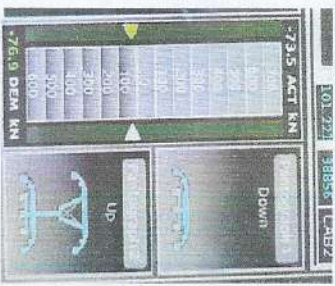
Test Function	Test Procedure/ Functional Requirement	Test Procedure Followed	Observation	Result	Photo
					<p>AT 1/3BE max>BE> 0</p>

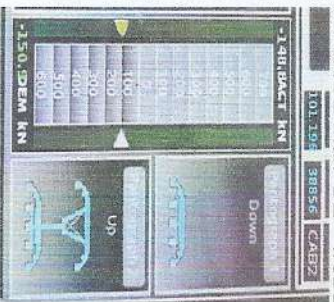
<p>AT 2/3BE max>BE> 1/3BE max</p>

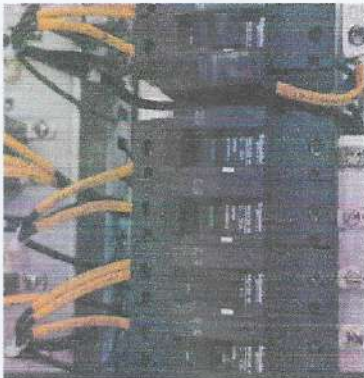
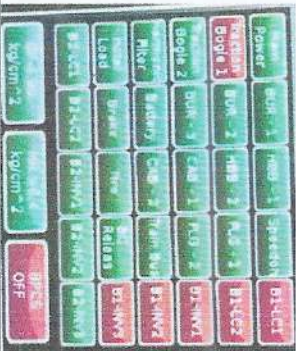
Test Function	Test Procedure/ Functional Requirement	Test Procedure Followed	Observation	Result	Photo
Configuration Mode		Loco was stand still with applied SA9 brake		Verified OK

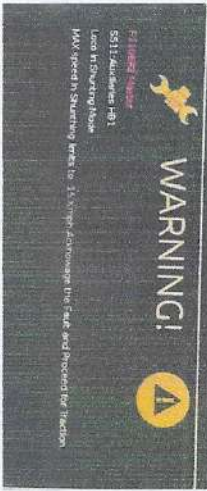
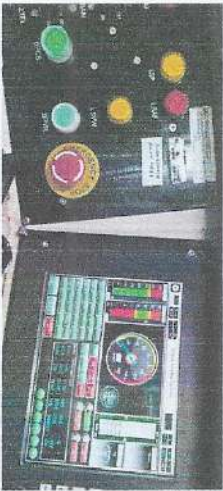
Test Function	Test Procedure/ Functional Requirement	Test Procedure Followed	Observation	Result	Photo
	<p>Rotary switch 160 to be moved at position 0</p> <p>Speed should be restricted to 15kmph</p> <p>Pop up message "Loco in shunting mode" should appear during every throttle movement</p>	<p>Throttle and reverser were in neutral position</p> <p>When node was 504 then shunting mode switch located in SB 1 moved from normal to active position</p>	<p>Checked in both simulation and power mode</p> <p>At 590 node throttle was taken</p> <p>After application of throttle loco is in shunting mode activated Pop-Up message is appeared.</p> <p>Maximum loco speed was reached up to 14.9 KMPH</p> <p>And Loco speed was restricted to 15 KMPH</p> <p>BPCS push button was pressed at 7.3 KMPH speed and loco speed became constant at 7.4 KMPH.</p>

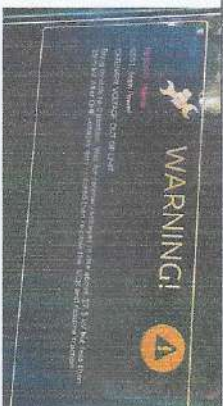
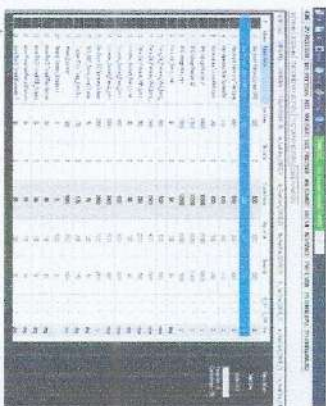
Description	Prescribed Value	Test Procedure Followed	Observation (Checked in Simulation/Traction Mode from Both CAB)	Remark	Photo
AC Primary Voltage (Driving mode)	Protective actions: 1) Minimum-voltage monitoring: $U \leq 17 \text{ kV(RMS)}$: VCB off closing of VCB inhibited if $U \leq 17.5 \text{ kV}$ 2) Maximum-voltage monitoring: $U \geq 30 \text{ kV(RMS)}$: VCB off closing of VCB inhibited if $U \geq 29 \text{ kV}$	For testing the protective action for the upper and lower limit of locomotive parameters Simulated forced signal was given to the controller of processor cards of the traction converter through software tool and GUI.	Values of OHE at which VCB tripped 1) VCB tripped for $U \leq 25 \text{ kV}$. (Actual value is 25 KV, forced value is 26 KV, Default value will be 17kV) 2) VCB tripped at $U \geq 31.5 \text{ kV}$, (Actual value is 25 KV Forced value is 24 KV. Default value will be 30kV) "Catenary voltage out of limit" Pop-Up message appeared on DDU	Verified OK

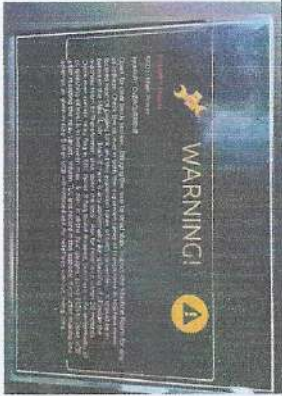
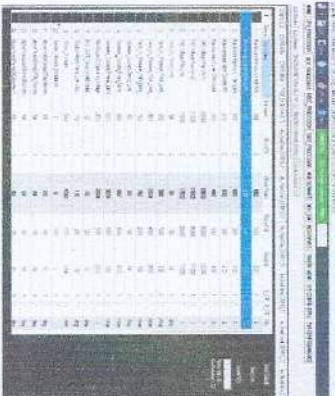
Description	Prescribed Value	Test Procedure Followed	Observation (Checked in Simulation/Traction Mode from Both CAB)	Remark	Photo
AC Primary Return Current	Protective actions: 1) Maximum-current monitoring within 1.25 sec after switch-on of VCB (inrush current of transformer): $1 \geq 800 \text{ A(RMS)}$: VCB off 2) Maximum-current monitoring during normal operation: $1 \geq 330 \text{ A(RMS)}$: VCB off	For testing the protective action for the upper and lower limit of locomotive parameters Simulated forced signal was given to the controller of processor cards of the traction converter through software tool and GUI.	Values of AC Primary Return Current at which VCB tripped 1) VCB tripped for $1 \geq 810 \text{ A}$ To simulate the condition, the level has been changed in forced value. (Actual value – 10A Forced value- 8A Default value – 810A 2) VCB tripped for $1 \geq 338 \text{ A}$ (Actual value – 10A Forced value- 5A Default value – 338A) "Primary overcurrent" Pop-Up message appeared on DDU.	Verified OK

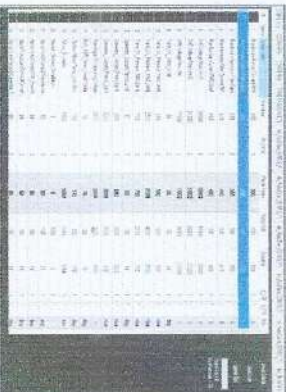
Description	Prescribed Value	Test Procedure Followed	Observation (Checked in Simulation/Traction Mode from Both CAB)	Remark	Photo
Harmonic Filter Current	Protective actions: 1) Maximum-current monitoring within 1 sec after switch-on of harmonic-filter: $I \geq 600 \text{ A(RMS)}$: VCB off, contactor harmonic filter off 2) Maximum-current monitoring during normal operation: $I \geq 410 \text{ A(RMS)}$: VCB off, contactor harmonic filter off	For testing the protective action for the upper and lower limit of locomotive parameters Simulated forced signal was given to the controller of processor cards of the traction converter through software tool and GUI.	Values of Harmonic Filter Current at which VCB tripped To simulate the condition, the level has been changed in forced value. 1) VCB tripped for 12600A (Actual value – 168A Forced value – 150A Default value – 600A) 2) VCB tripped for 12410A (Actual value – 190A Forced value – 130A Default value – 410A) Harmonic filter current too high Pop-Up message appeared on DDU.	Verified OK.

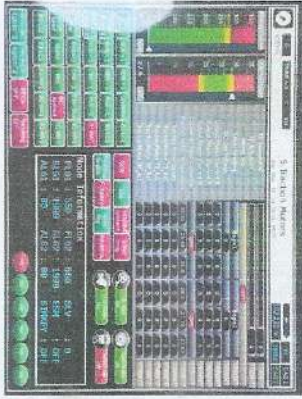
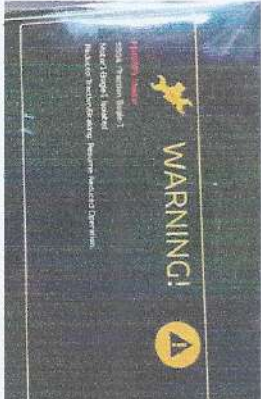
Description	Prescribed Value	Test Procedure Followed	Observation (Checked in Simulation/Traction Mode from Both CAB)	Remark	Photo
Traction Motor Temperature	Protective actions: 1) IGBT-pulsing inhibited: 230 °C	For testing the protective action for the upper and lower limit of locomotive parameters Simulated forced signal was given to the controller of processor cards of the traction converter through software tool and GUI.	VCB tripped for motor temperature $T \geq 230^{\circ}\text{C}$ (Actual value – 21.8°C Forced value- 20°C Default value – 230°C)	Verified OK

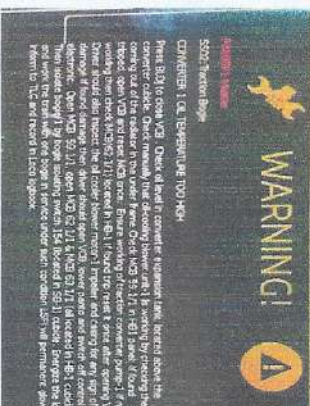
Description	Prescribed Value	Test Procedure Followed	Observation (Checked in Simulation/Traction Mode from Both CAB)	Remark	Photo
Converter Oil Temperature	Protective actions: 1) VCB Off: T 80°C longer than 10 sec	For testing the protective action for the upper and lower limit of locomotive parameters Simulated forced signal was given to the controller of processor cards of the traction converter through software tool and GUI.	When converter oil temperature exceeded the following results. VCB tripped at T=281 °C. Actual temp was 29.45 °C, limit changed to 25 °C. After One iteration particular bogie got isolated. "Converter oil temperature too high" Pop-Up message appeared on DDU.	Verified OK

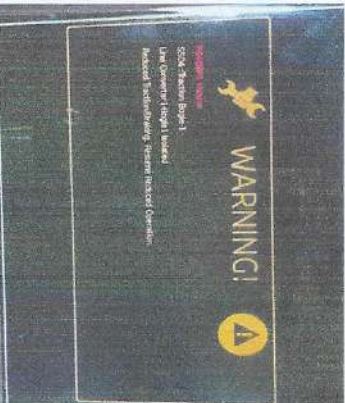
Description	Prescribed Value	Test Procedure Followed	Observation (Checked in Simulation/Traction Mode from Both CAB)	Remark	Photo
DC Link Voltage Main Converter	Protective actions: Udc < 2500 V : DC-link Under Voltage Udc > 3200 V : DC Link Over Voltage	For testing the protective action for the upper and lower limit of locomotive parameters Simulated forced signal was given to the controller of the traction converter through software tool and GUI.	When DC link voltage dropped below and exceeded above the following values VCB tripped at Vs=2450V, limit change 2500-volt, actual value is 2000 volt. 2) VCB tripped at Vs=3199V, limit change 1500 volt, actual value is 1950. volt. Disturbance in Converter, Line Converter-1 Bogie-1 Isolated Pop-Up message appeared on DDU	Verified OK

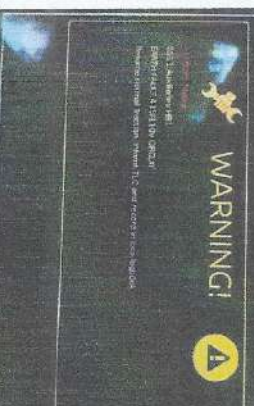
Earth Fault 415V/110V Circuit	Protective actions: Binary signal 0 : normal operation Binary signal 1 : diagnostic data set (DDS) 'earth fault 415V/110V circuit'	To simulate this, in HB1 panel, relay 89.5 A & B points are shorted.	Earth Fault 415V/110V Circuit Pop-Up message appeared on DDU. As per shed, the E/F indication need to be incorporated in DDU.	Verified OK

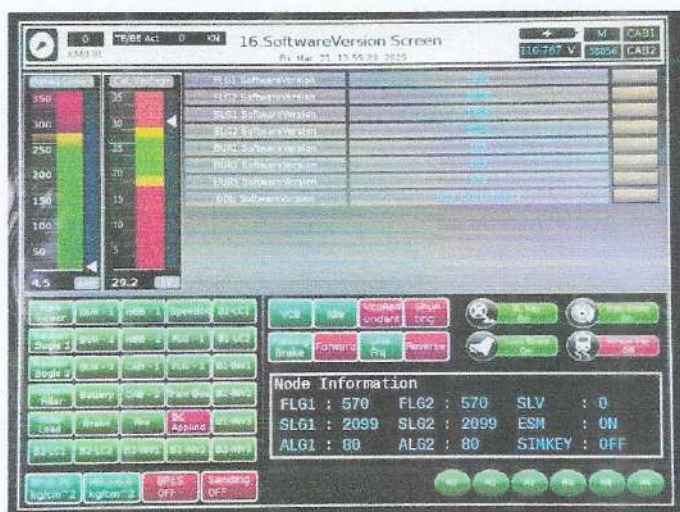
1. The snapshot of software version which has been uploaded in the loco no. 38856 is as follow and the versions are -

Description		Software version
SR 1 software version	:	1006
SR 2 software version	:	2006
BUR1 software version	:	103
BUR2 software version	:	203
BUR3 software version	:	303
VCU 1 software version	:	1036
VCU 2 software version	:	2036
DDU1 software version	:	DDU_CAB11703.11
DDU2 software version	:	DDU_CAB11703.11

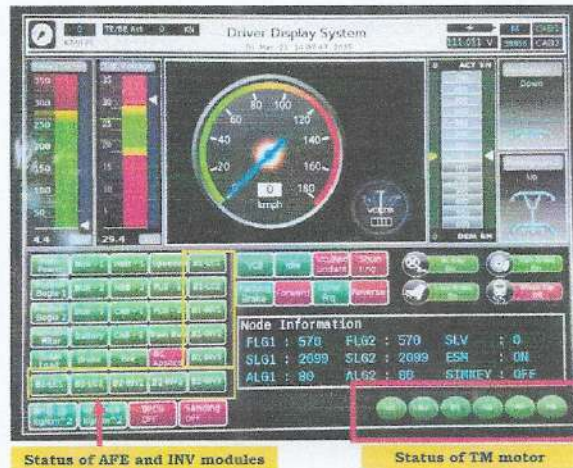
2. Graphical user interface (GUI) to monitor the healthiness of each motor has been implemented in DDU and same has been verified. Also Screen shot of same is attached below for reference

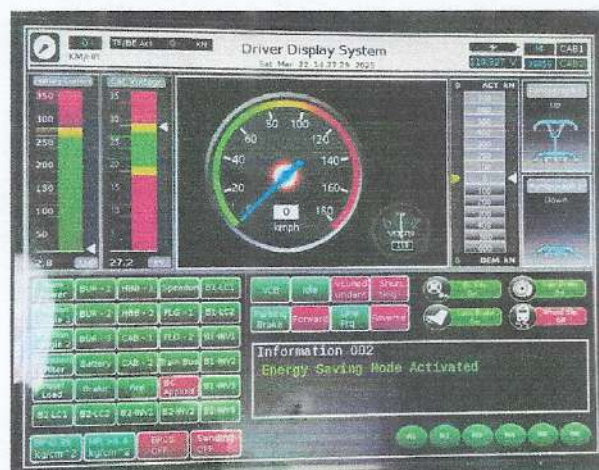
3. Recordings of 43 critical signals as per RDSO letter no. EL/3.1.35/17 dated 28.04.2023 has been implemented. The storing is being done for 72 hours and it is being downloaded through Ethernet cable and the data displayed in Excel format which is provided as Annexure-AA. Further it is to be noted that there are 62 parameters altogether which is being recorded.
4. Logic for energy-saving scheme, based on RDSO Modification Sheet no. 0482, rev 1, has been provided. Further whenever energy saving mode gets activated, in pixy window of DDU the status of the ESM will be ON indicating "ESM (Energy Saving mode): ON" showing a pop up message of "Energy Saving Mode Activated".

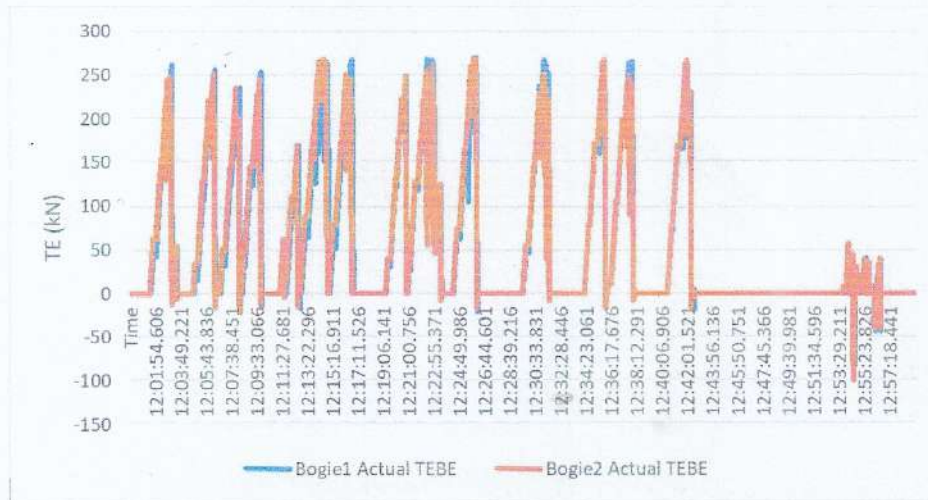
In addition to this the TE curve for complete testing period is attached for reference.

In view of above of it can be observed that slip slide control has been found satisfactory. Currently, the test is being conducted with two locomotives connected back-to-back in regeneration mode, with the loads being simulated. However, more precise tuning may be required to match actual service conditions during field trials.

Additionally, it is to be noted that due to speed and track limitations at CLW, the complete performance could not be assessed at higher speeds. Therefore, firm may be advised to conduct foot plating of the locomotive when it is dispatched from CLW. Furthermore, ELS/Shop-19/CLW may be instructed to carry out pre-dispatch tests as per the testing and commissioning format along with the modifications with the necessary MS issued by RDSO.
